# The Regional Center for Conservation and Restoration of Jerash, Jordan

editors Mario Micheli and Bilal Fawwaz Mohammad Alboreeni

This volume resulted from the project 'Creation of the Regional Center for Conservation and Restoration in Jerash', entrusted to Roma Tre University by the Italian Agency for Development Cooperation

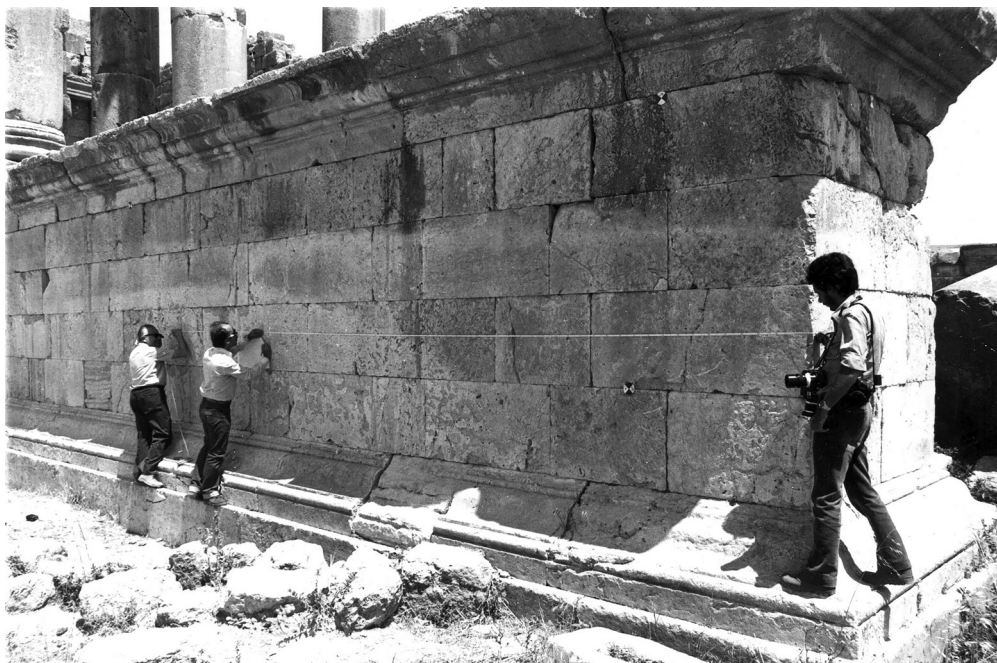
**Fig. 1**

Giorgio Gullini, Roberto Parapetti, and Guido Fino measuring graffiti positions on the southern side of the Temple of Artemis podium (1977).

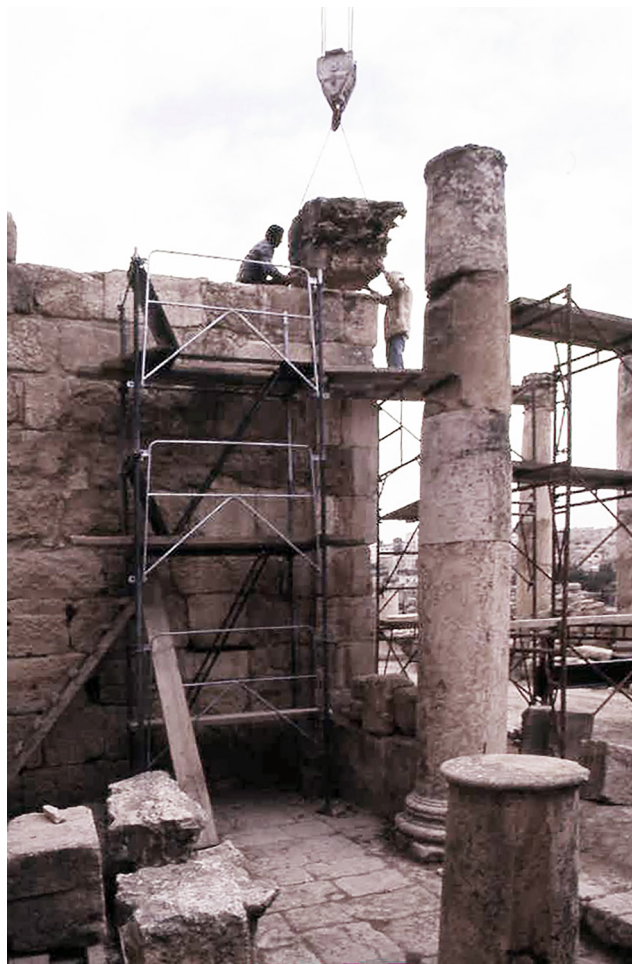
**Fig. 4**

Repositioning of the exedra anta capital in the centre of the southern wing of the Cardo workshops, funded by Italian Development Cooperation (1988).

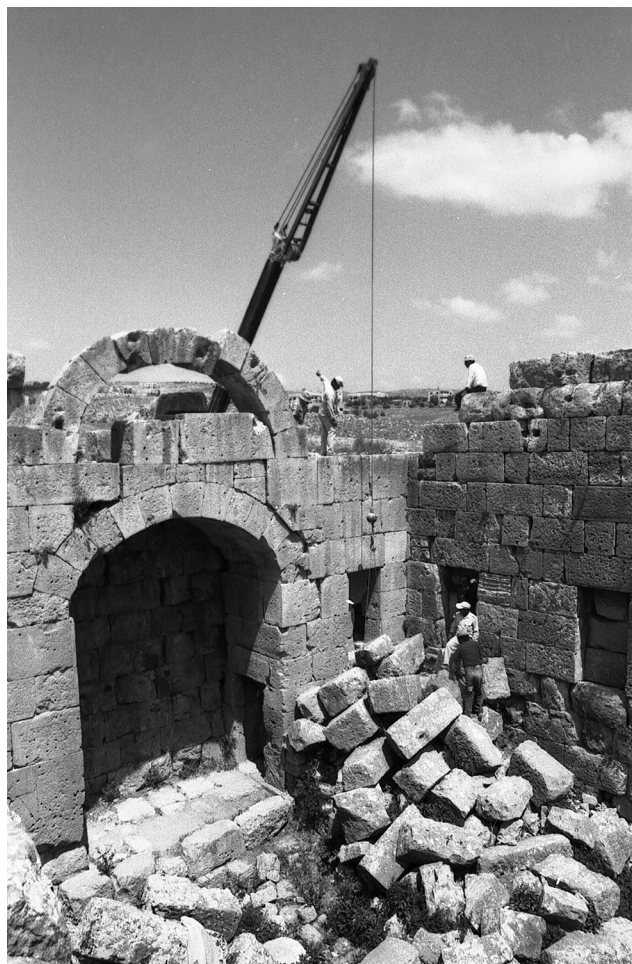
**Fig. 8**

Commencement of excavation in the Temple of Artemis cella, removing collapsed wall blocks due to a 12th-13th century earthquake (1994).

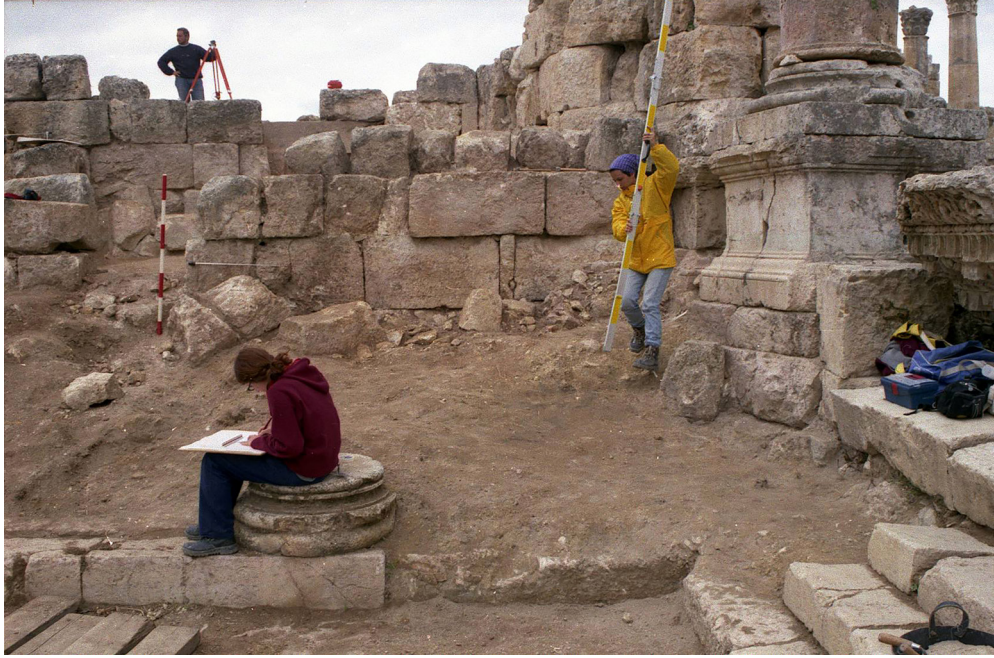
**Fig. 9**

Surveying works during stratigraphic excavation of the southern side of the Trapezoidal Plaza (1999).

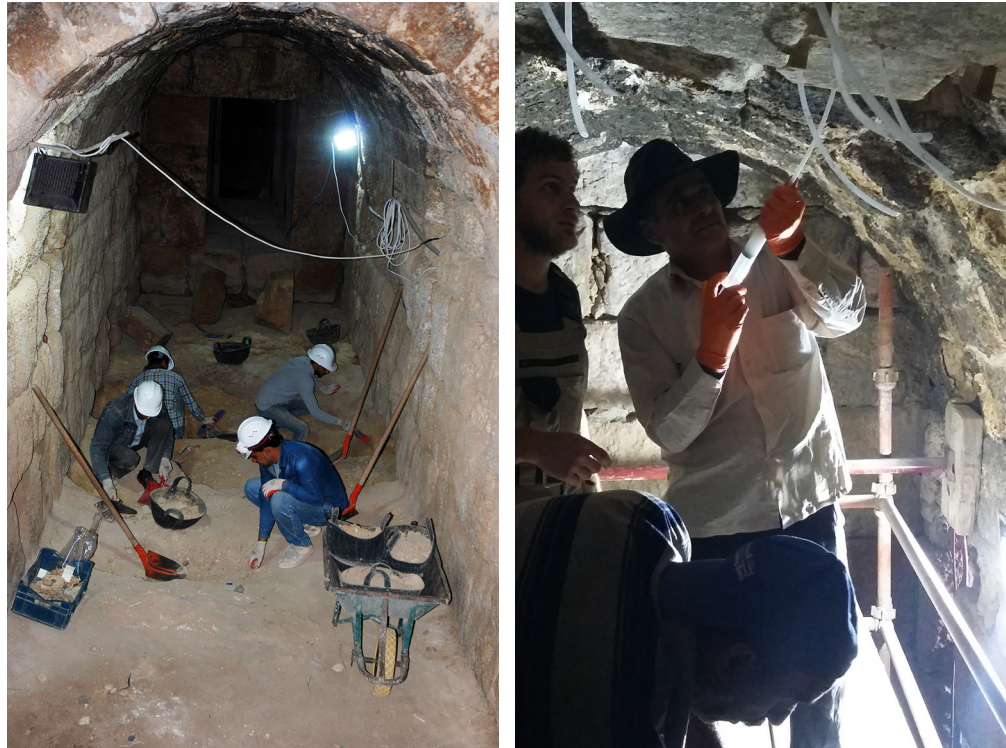
Consolidation of the podium vaults via injections of natural hydraulic lime mortar and training of specialised workers during the AFCP project (2019).

From 2012 onwards, the temple has been under continuous monitoring by the technical staff of the Italian Mission due to the accelerated rate of decay, most apparent in the vault voussoirs, podium walls, and the walls of the cella. In the latter, superficial fragmentation was evidenced by accumulations of small limestone fragments at the base of the walls. The scale and complexity of the necessary interventions demanded a dedicated budget, which was unavailable at the time from either the Department of Antiquities or the Italian Mission, and highlighted the critical issue, emphasised by the then director of excavations at Jerash, Ali al-Khayyat, of the absence on-site of Department personnel with the technical expertise required to design and implement appropriate conservation measures.

The primary condition observed was the widespread decay of the limestone elements. Cracking and disintegration of the stonework could be measured by comparing graphic and photographic documentation of the temple over the past twenty-five

years, since the excavation of the cella. The principal agent of decay is exposure to rainfall and infiltration, affecting both the walls of the cella and the podium vaults. Subsequent temperature fluctuations induce cycles of wetting and drying that accelerate limestone deterioration. Consequently, rainwater management emerged as the principal priority for mitigating the temple's deterioration.

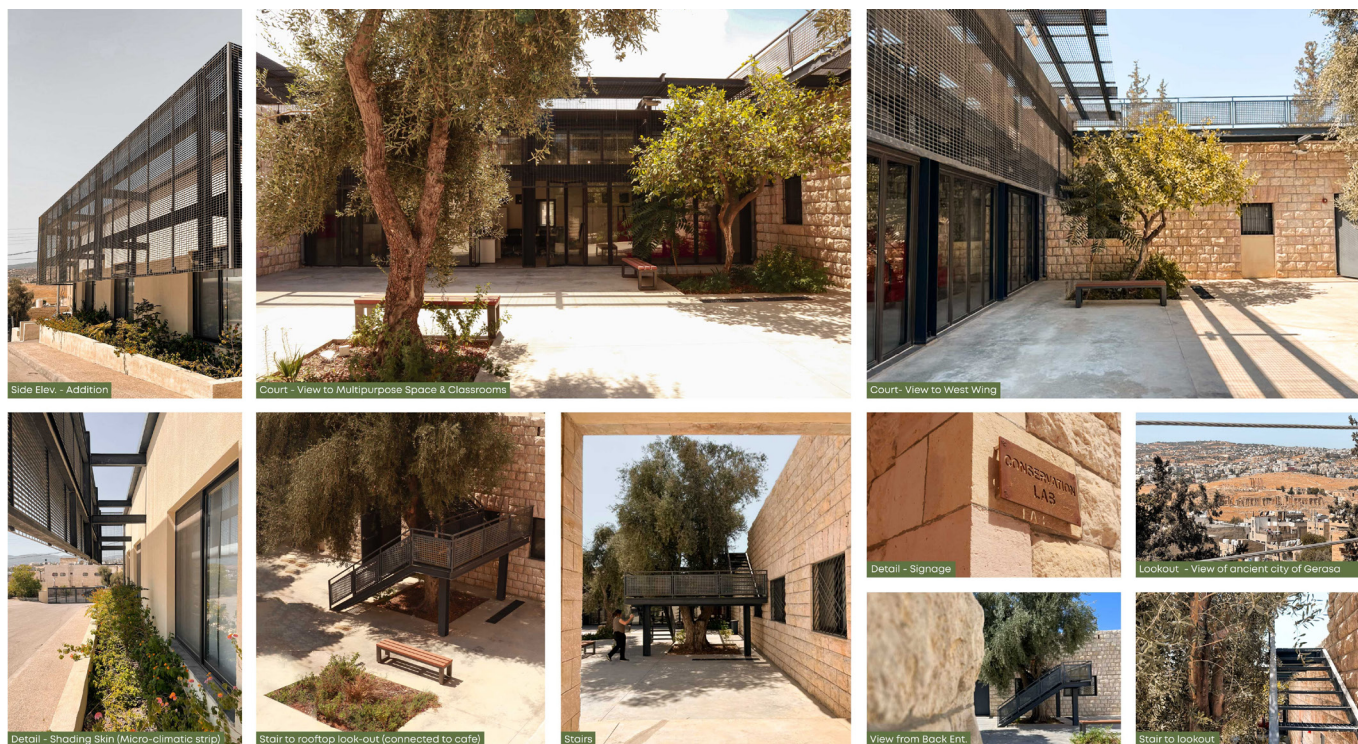
**Fig. 8**

RCCR Adaptive Reuse  
Exterior Images after  
completion. Source:  
TURATH for Studies &  
Design.

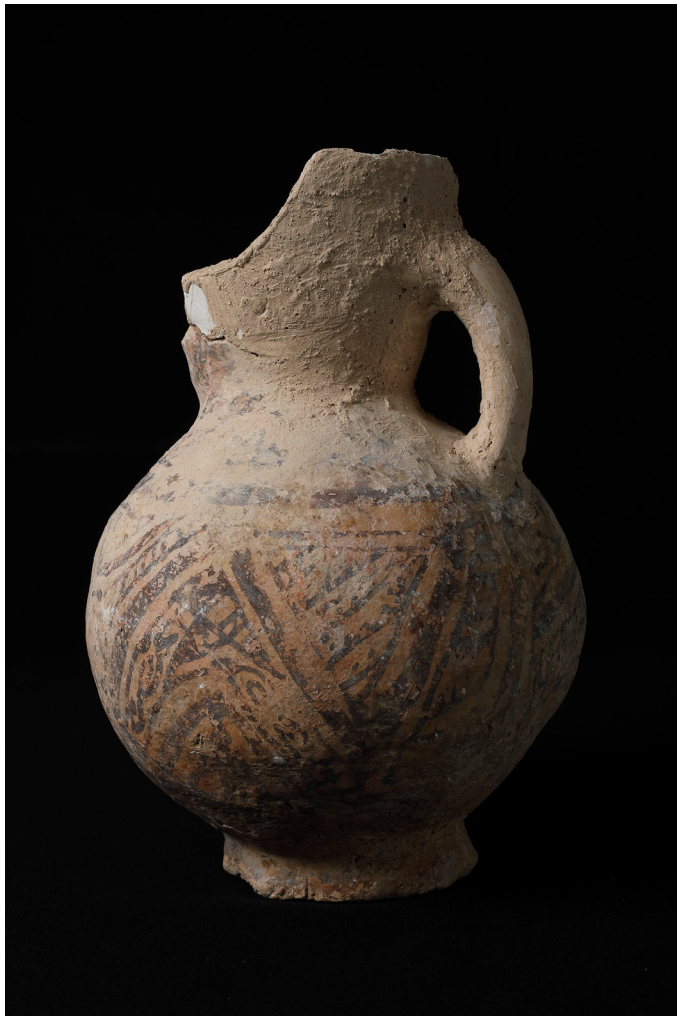
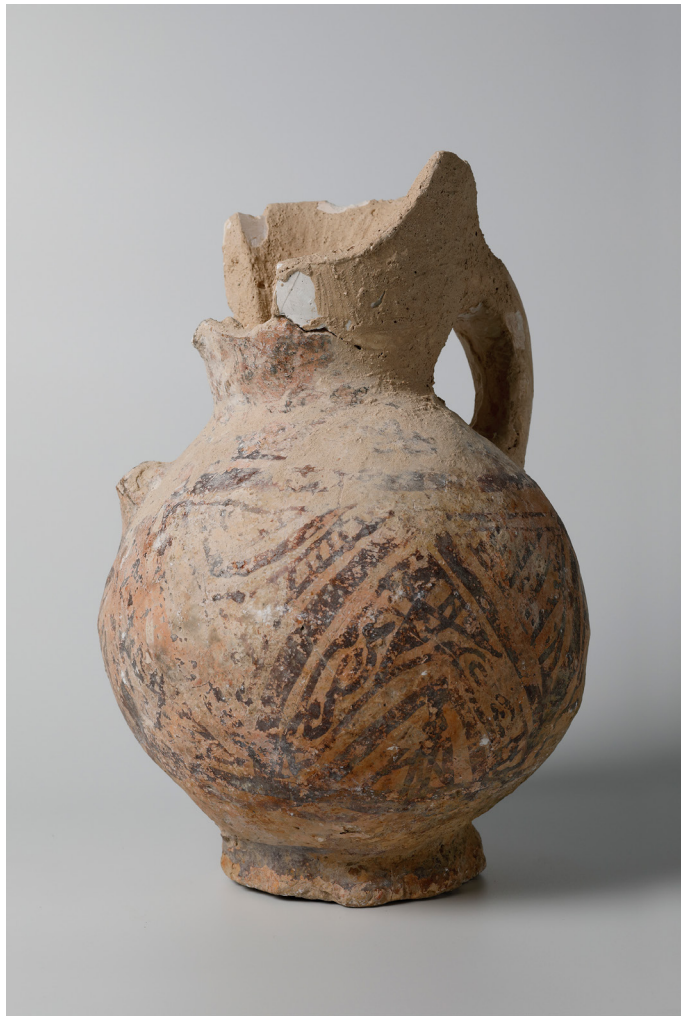
**Figs. 1, 2**

Photographs taken in the laboratory using flash lighting and light modifiers. Colour was calibrated using an absolute reference (ColourChecker).

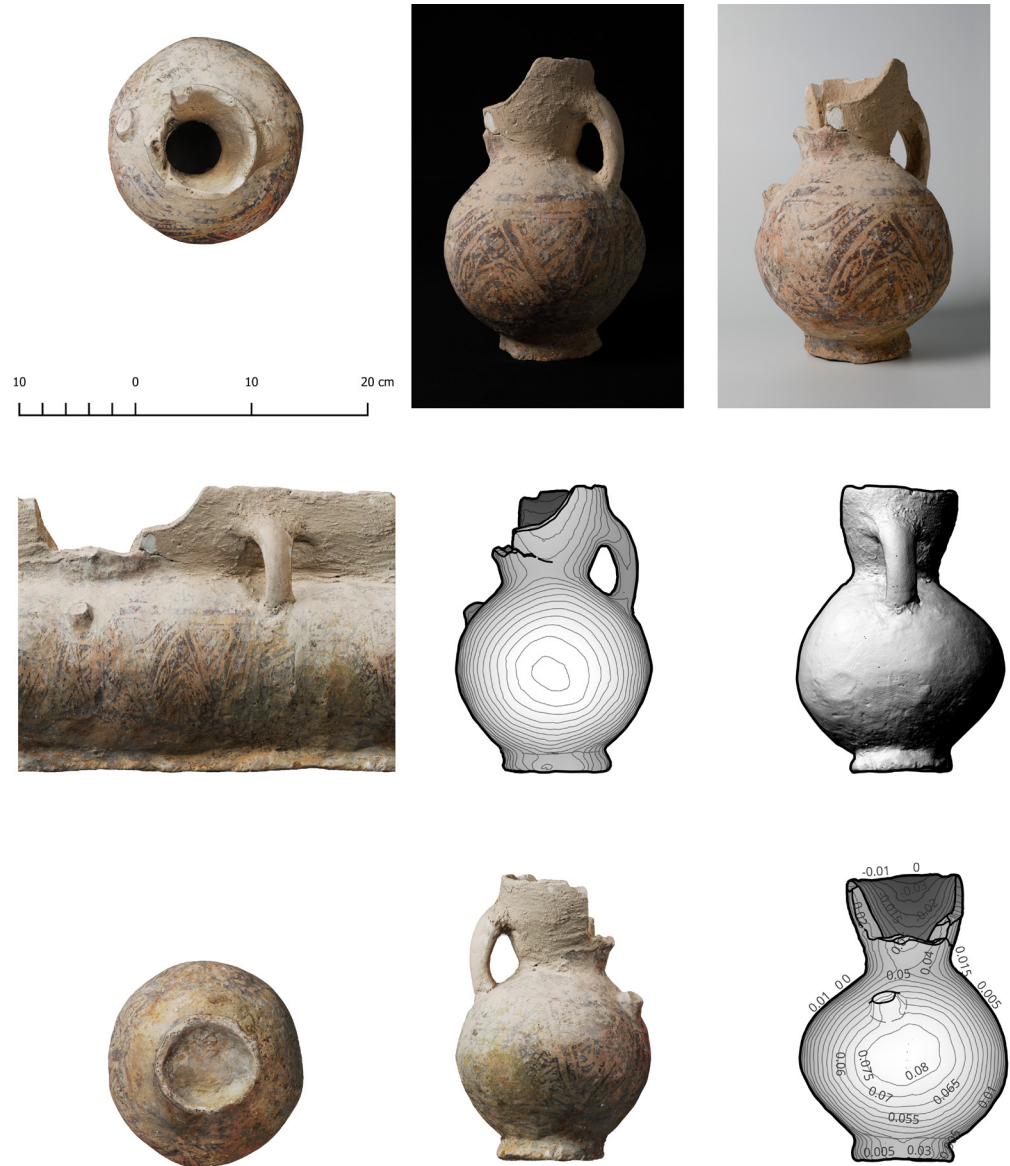
**Fig. 6**

Plan representation of a three-dimensional object: projections onto six planes and a cylindrical development were obtained.

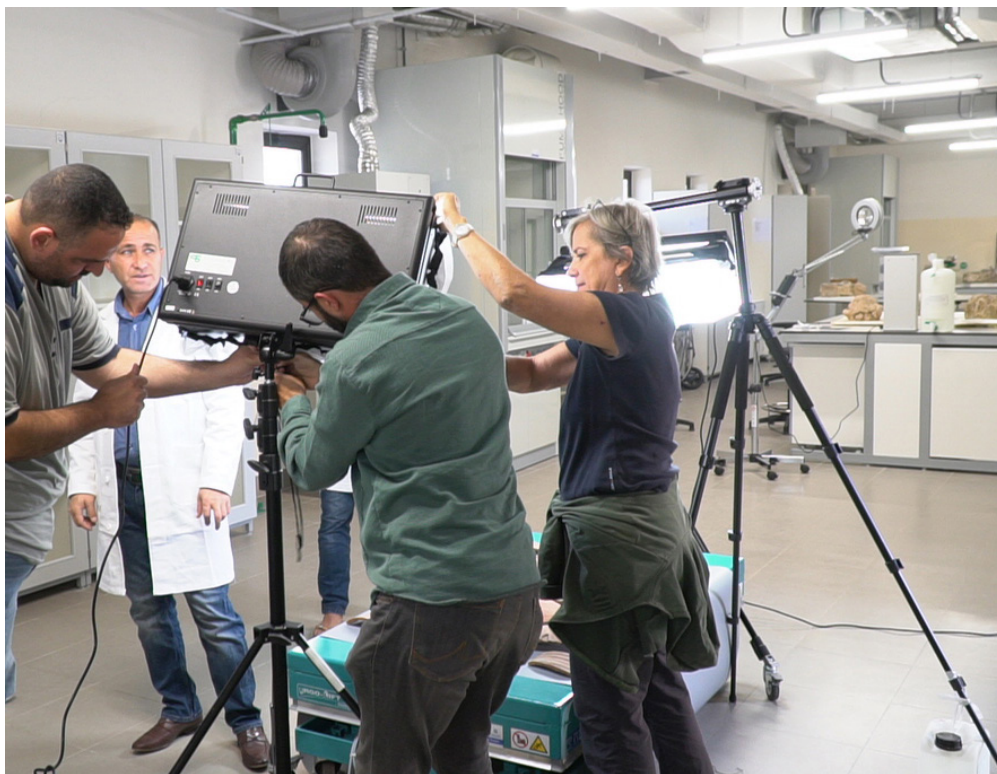
**Fig. 1**

Preparation of the equipment required for the photographic documentation of archaeological finds.

At the same time, a detailed photographic record was kept throughout the entire process. It went from the initial condition of the artefacts, through the main stages of intervention, to the final outcome. The images served not only a descriptive purpose, but also an educational and analytical one, by making sure that the progression of the restoration process be clearly visualised and a collective discussion about the decisions made be held (Fig. 1).

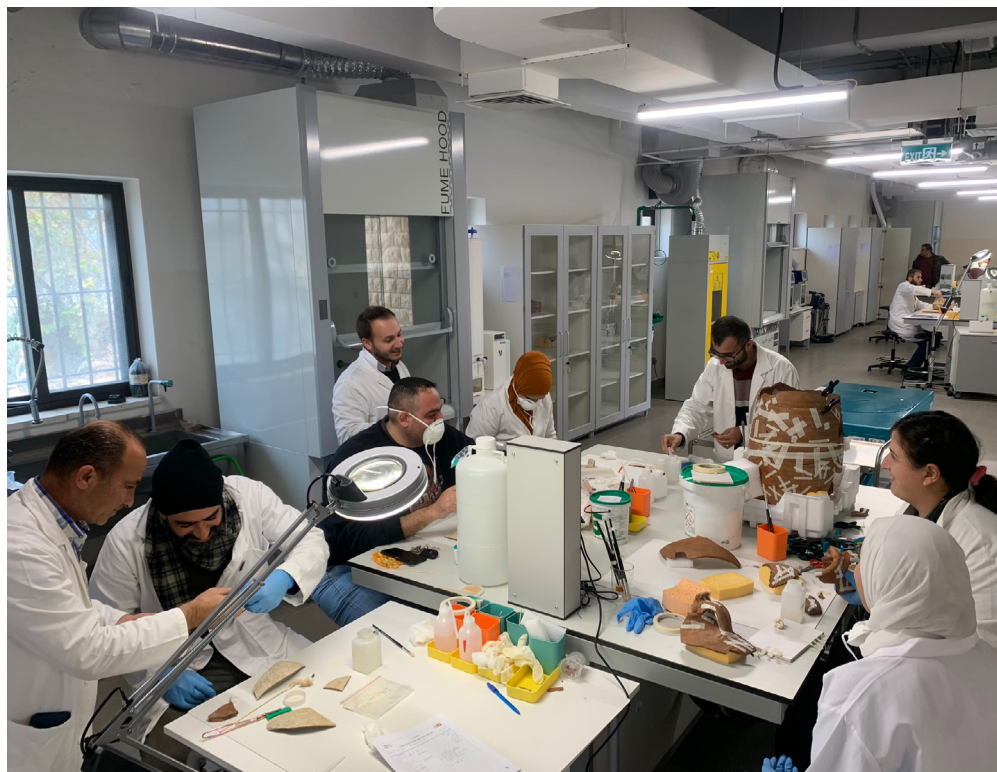
**Fig. 2**

Assembling fragments of archaeological pottery. Practical laboratory exercise.

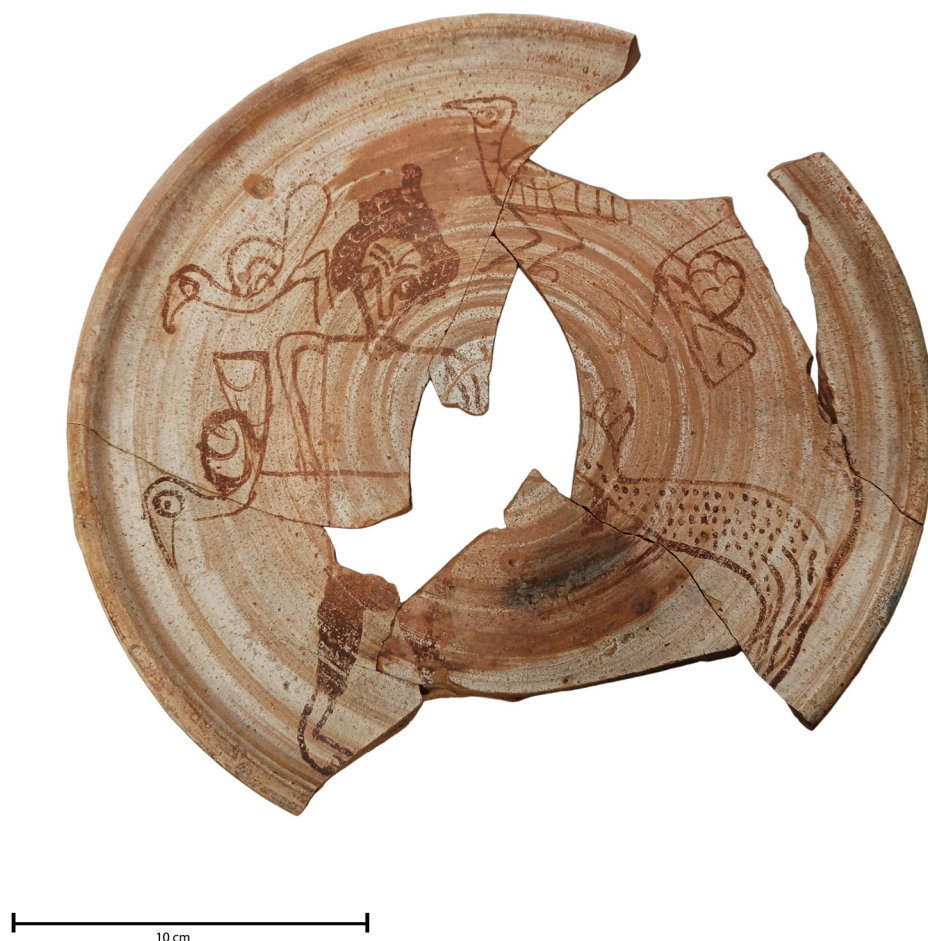
**Fig. 3**

Jerash, locally produced plate (RCCR temporary inv. nr. 21). Fragments belonging to the artefact following cleaning and bonding.

Adhesion and bonding were mainly done using 20% Paraloid B72 solutions in acetone, or 20% Mowital B60HH solutions in ethanol. For large artefacts, which required bonding with greater structural strength, a two-component epoxy resin (UHU PLUS ENDFEST 300 12h) was used, always preceded by the application of a primer<sup>1</sup> coating to ensure the reversibility of the treatment.

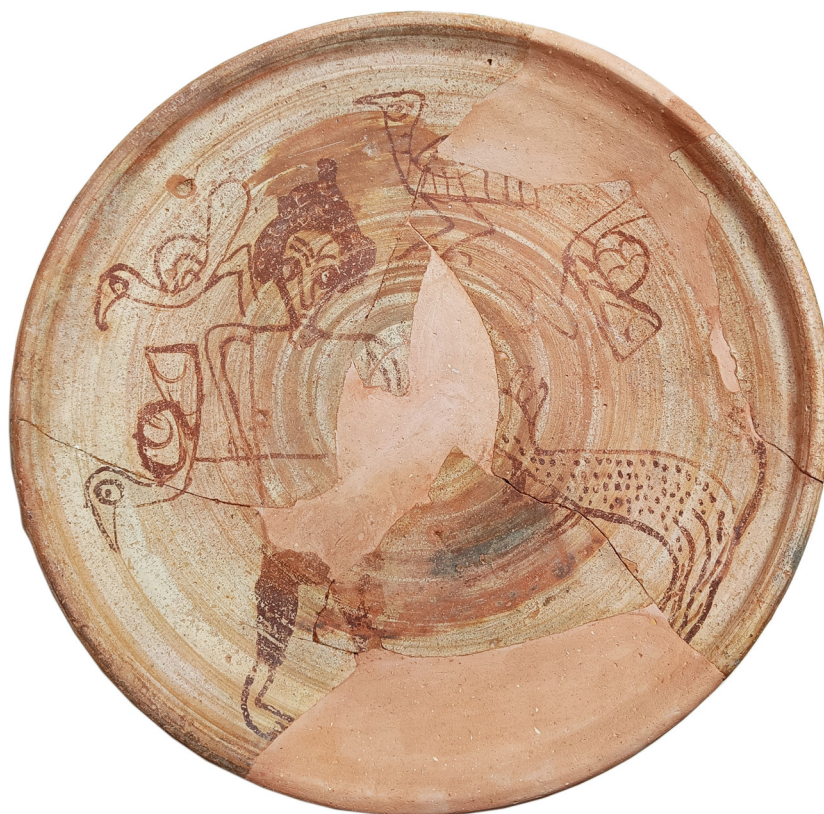
**Fig. 4**

Jerash, locally produced plate (RCCR TEMPORARY NUMBER 21). Fragments belonging to the artefact following formal restoration using pigmented gesso.

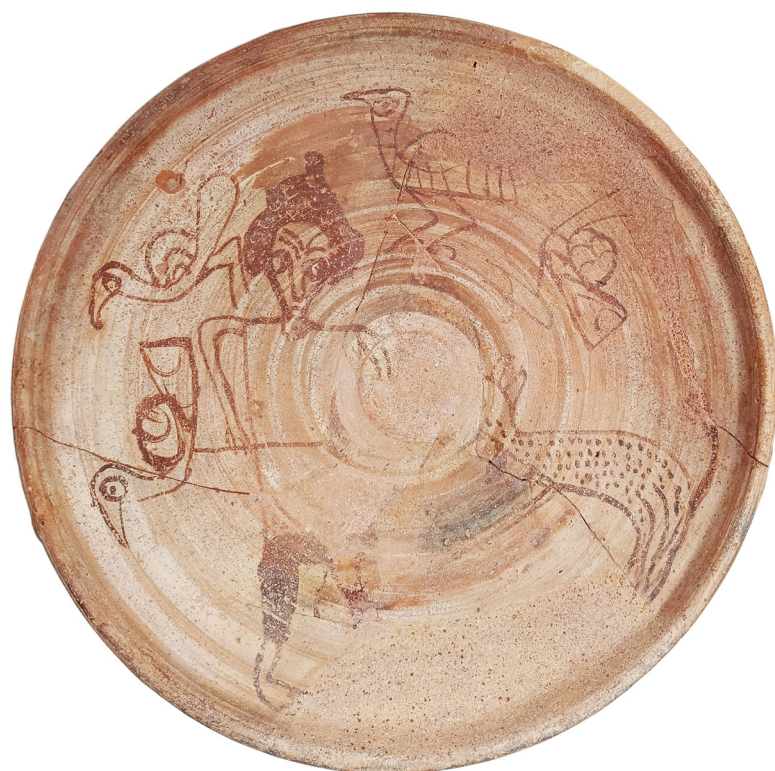
**Fig. 5**

Jerash, locally produced plate (RCCR TEMPORARY NUMBER 21) . Fragments belonging to the artefact following formal and chromatic restoration using the stippling technique.

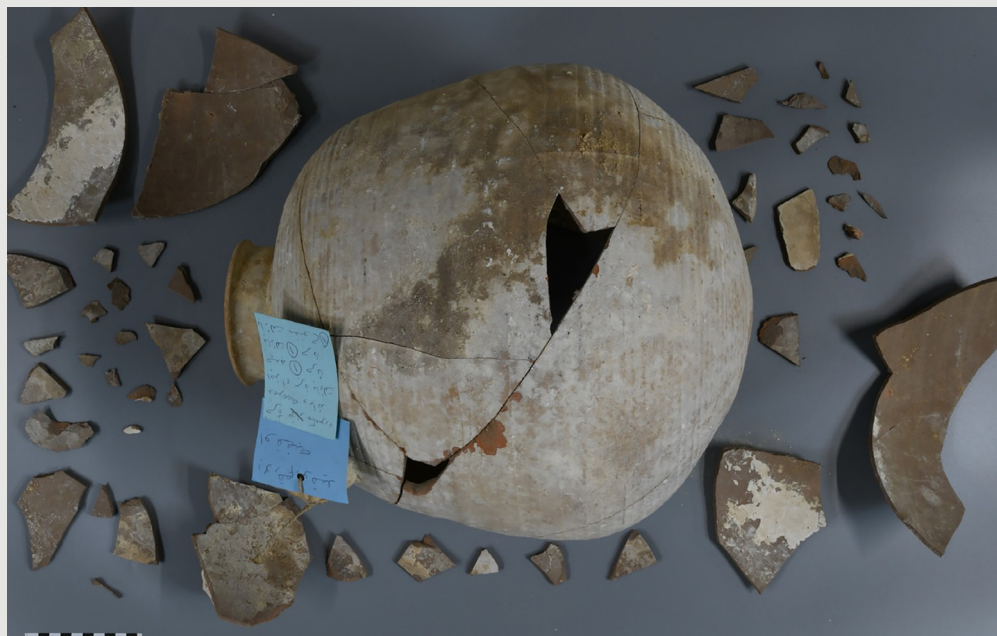
**Fig. 2**

Light-Colored Jar (RCCR temporary Inv. No. 4)  
during conservation,  
illustrating cleaning,  
reassembly, and filling.

A protective coating of acrylic resin Paraloid B72 (3% in acetone) was applied to the surfaces of both vessels, with higher concentrations along fracture edges. Fragment reassembly was performed after careful matching using Paraloid B72 (20% in acetone). In structurally critical areas, limited use of a bicomponent epoxy resin (UHU PLUS ENDFEST 300 12h) was necessary.

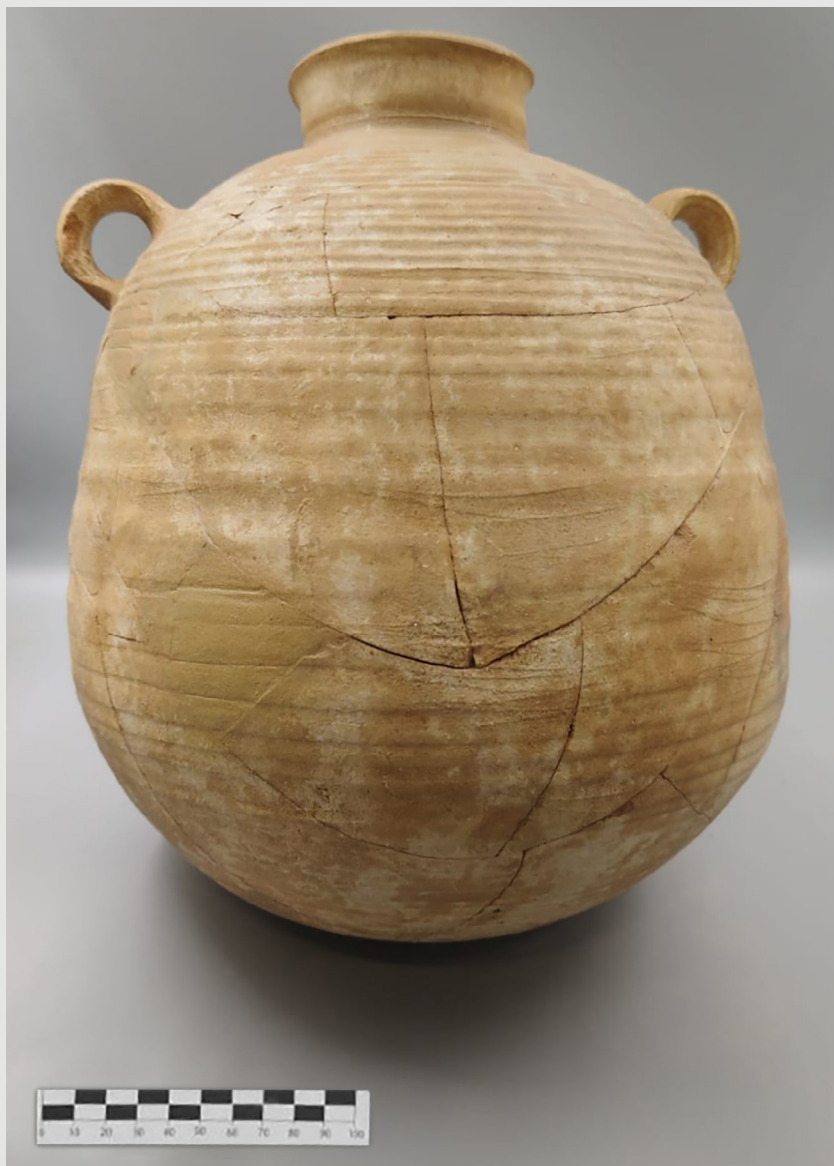
**Fig. 3**

Light-Colored Jar (RCCR temporary Inv. No. 4) after conservation, showing the stabilized and restored vessel.

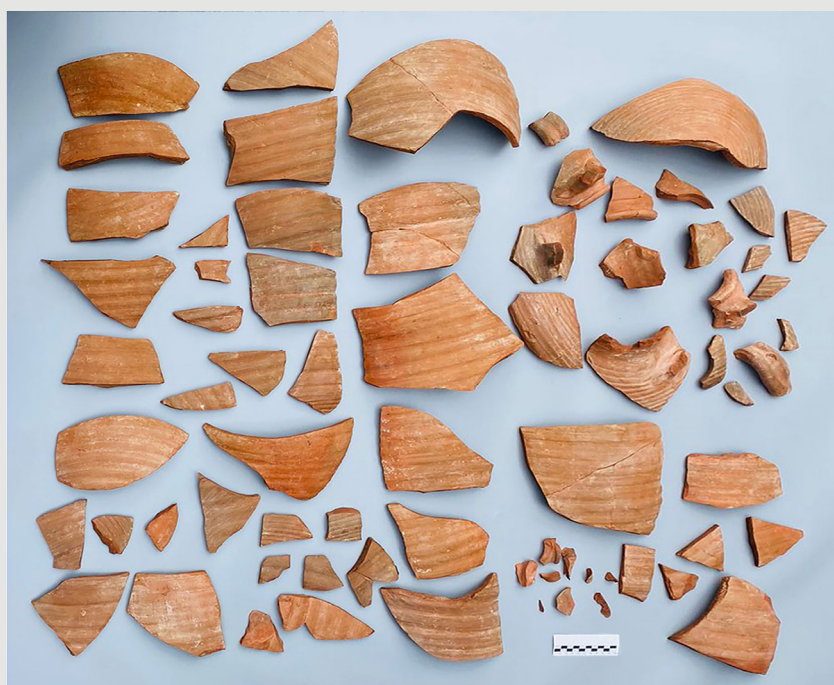
**Fig. 4**

Red-Brown Jar (RCCR temporary Inv. No. 5) before conservation, showing fragmentation and surface encrustations.

This jar arrived in multiple fragments, with missing elements and lacunae affecting the body and rim, as well as traces of previous restoration. At the time of examination, the surface exhibited thick dust layers, calcareous encrustations,

adhesive residues, abrasions, scratches, and localized chipping. Manufacturing features such as wheel-thrown lines, joining seams between sections, and inclusions within the ceramic fabric were observed, confirming wheel-thrown production and multi-part construction.

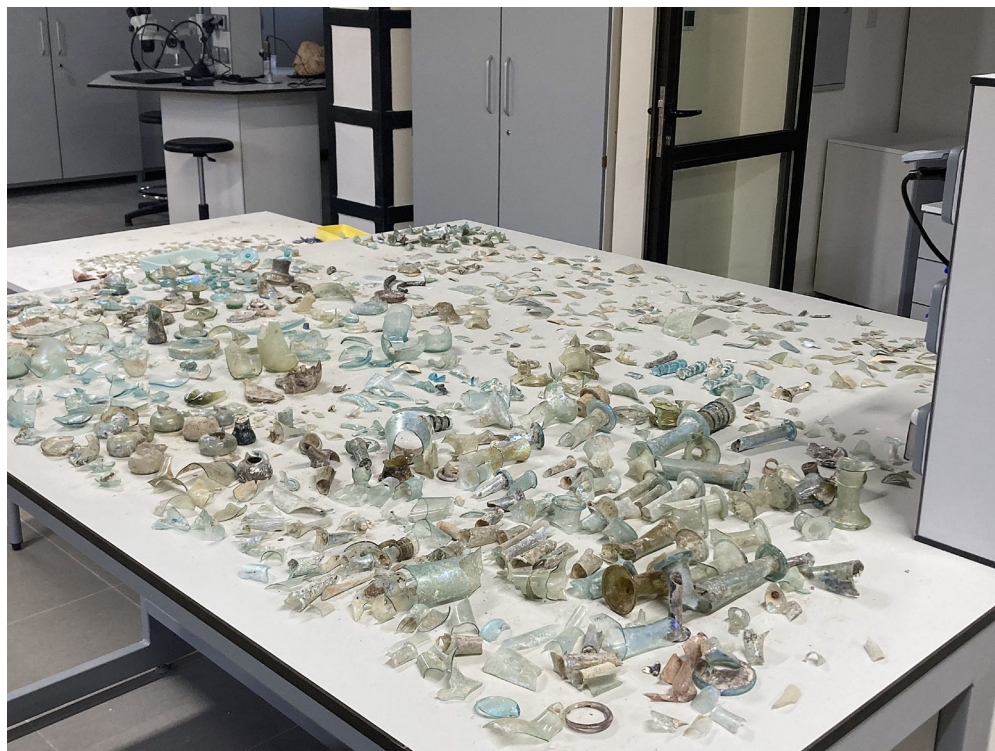
**Fig. 1**

Series of glass fragments from the archaeological site of the ancient city of Jerash during sorting and classification.

The material examined during the course consisted of a large number of glass fragments, mixed together and originating from hundreds of artefacts. These showed similar types of degradation, as they all came from the same archaeological site and had been subjected to comparable burial conditions, which resulted in largely uniform alteration processes.

The glass fragments still bore traces of their burial setting, including cohesive soil deposits, carbonate concretions, and dark stains likely caused by manganese oxides, which were particularly visually intrusive. The surfaces showed signs of leaching<sup>4</sup>, resulting in a slight but widespread iridescence, alongside localised areas of thicker hydrated silica layers<sup>5</sup>, with a characteristic nacre-like or opaque white look. Some areas showed signs of lifting and detachment of tiny chips, as well as micro-porosity and pitting.

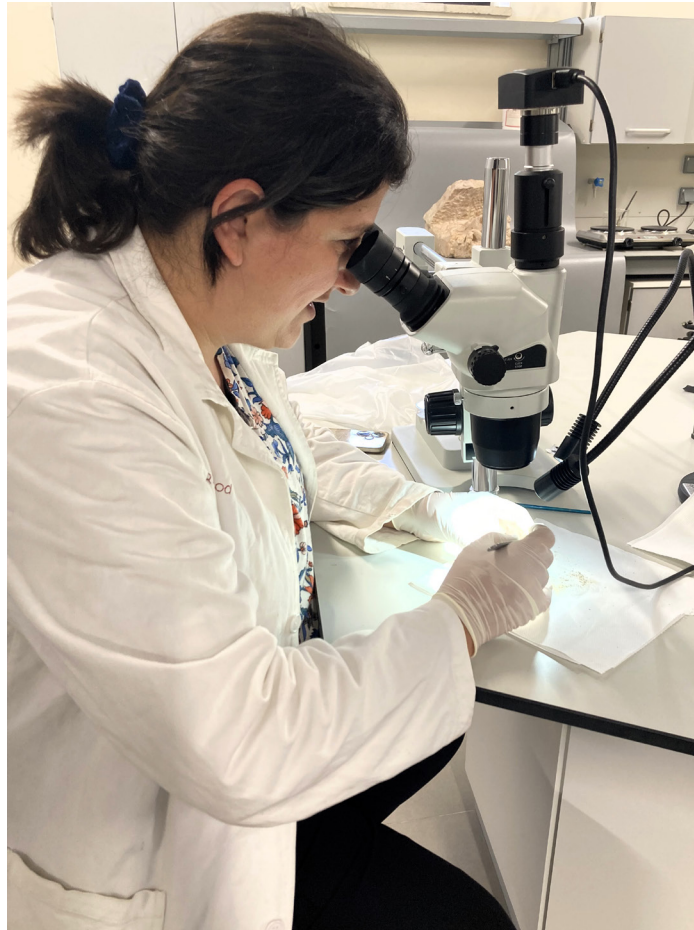
**Fig. 2**

Cleaning operations  
carried out using a  
stereomicroscope.

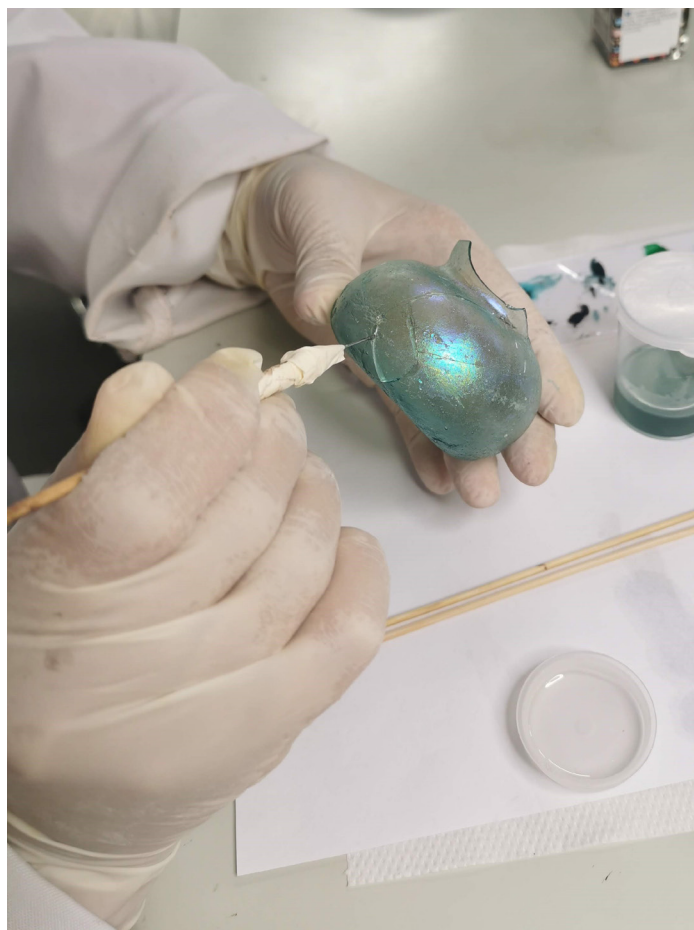
**Fig. 3**

Final bonding of a glass  
balsamarium using  
low-viscosity epoxy resin  
applied by percolation.

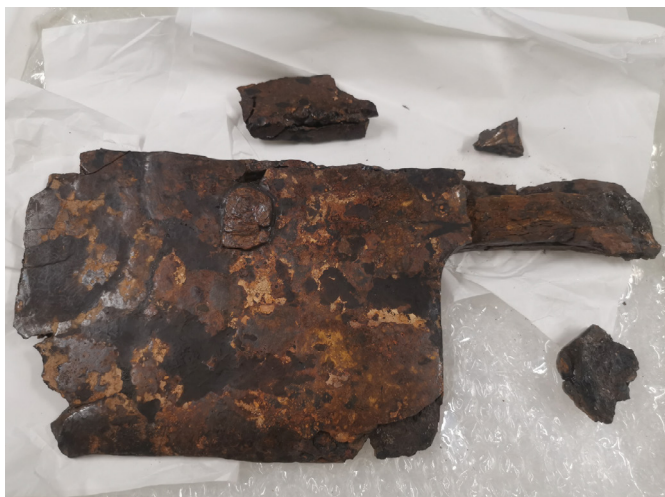
**Fig. 3**

The dark areas on the iron cleaver blade indicate the locations of previous fills.

- **Losses:**  
Losses of varying extents were found on almost all the objects. Past efforts to mitigate this problem are also observed on some objects (see Fig.2). On the iron cleaver from the museum, the blade was filled in an imitative way in the past, while the handle retains only adhesive residues. The loss of lion-face handle has been filled with a fibrous material, with highly mimetic inpainting on the front side (see Fig.4).

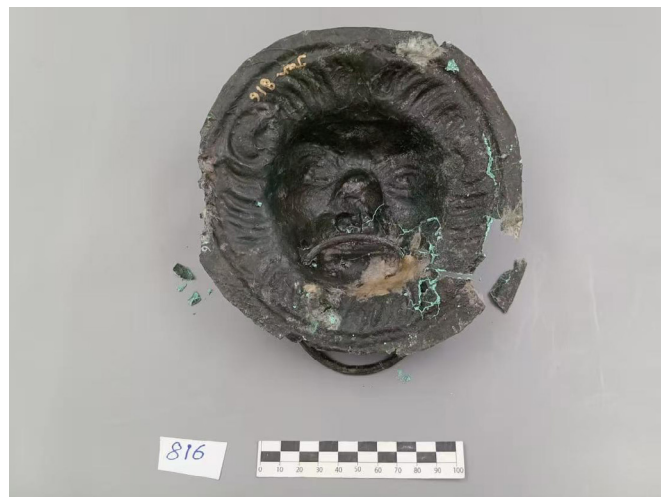
**Fig. 4**

Thick resin layer applied to the reverse of the lion-face handle.

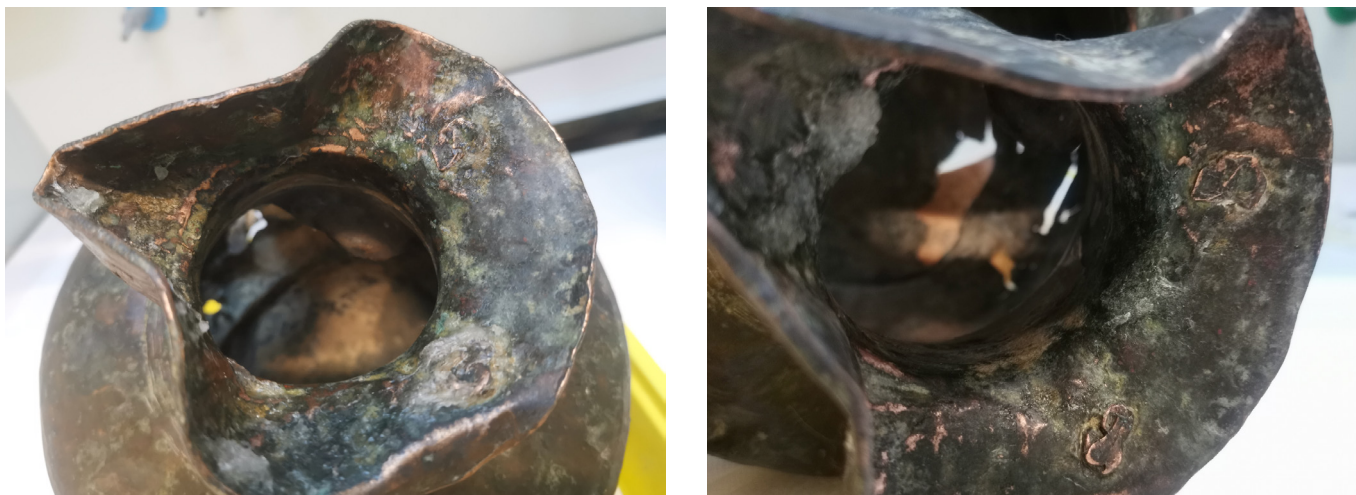
**Fig. 6**

A localized area on the rim of the roman bronze jar, before and after cleaning.

The cleaning of metal artifacts primarily targets surface deposits and non-chloride corrosion that compromises their legibility, typically involving both mechanical and chemical methods. Mechanical cleaning employs handheld tools such as brushes, bamboo sticks, scalpels, dental probes, and fiberglass rods, as well as equipment like electric rotary grinding bits, ultrasonic scalers, and sandblasters. Due to the high copper content and resultant susceptibility to scratching in Jordanian bronze artifacts, mechanical cleaning must be carried out with extreme care. Handheld tools are generally preferred; powered tools such as rotary grinder with silicon carbide or corundum bits, or ultrasonic scalers, should only be considered for thick and hard encrustations. It is important to note that the use of metal brushes and sandblaster is generally not recommended for bronze objects.

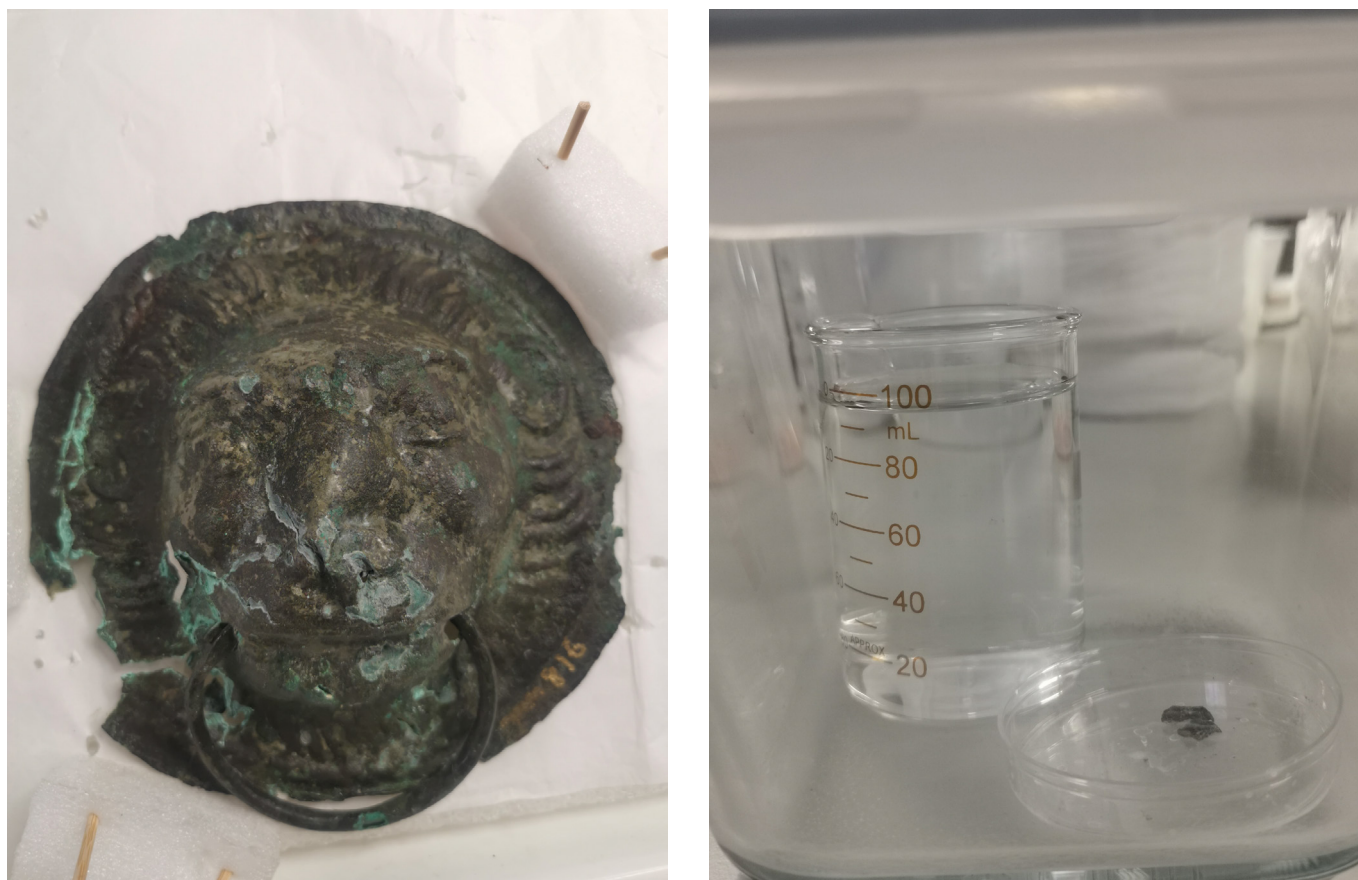
**Fig. 8**

Slight discoloration on the muzzle of the lion-face handle after localized application of L-Cysteine; humidity chamber test of small fragments detached from the border after immersion in L-Cysteine.

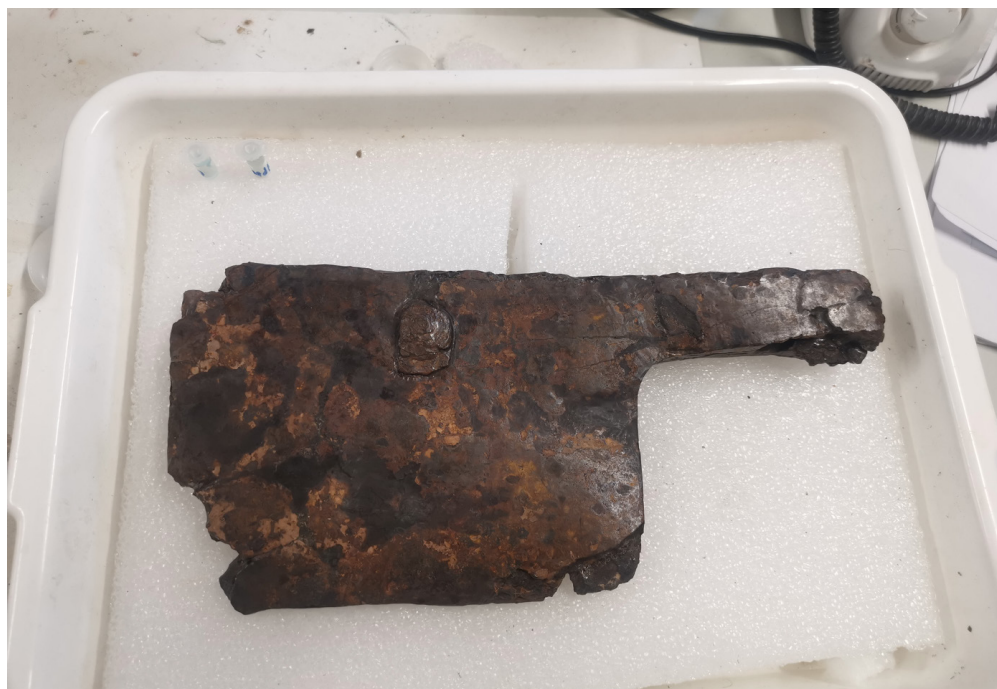
**Fig. 10**

Inpainting over the fill of the handle to create a visually homogeneous surface.

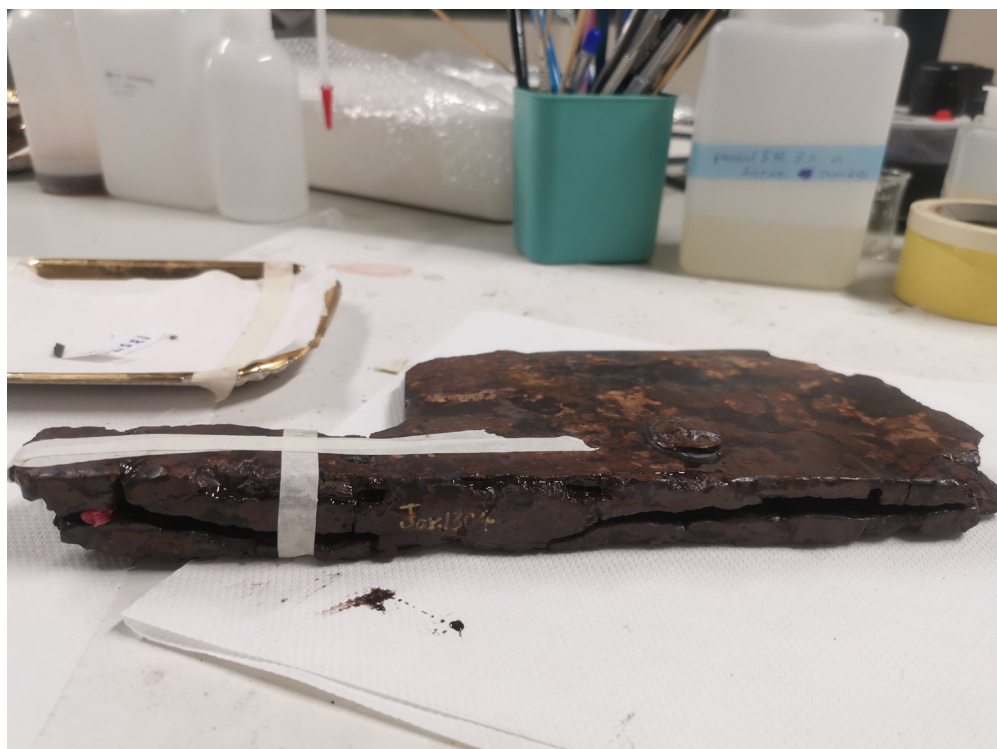
**Fig. 12**

Alignment of the joints during reassembly.

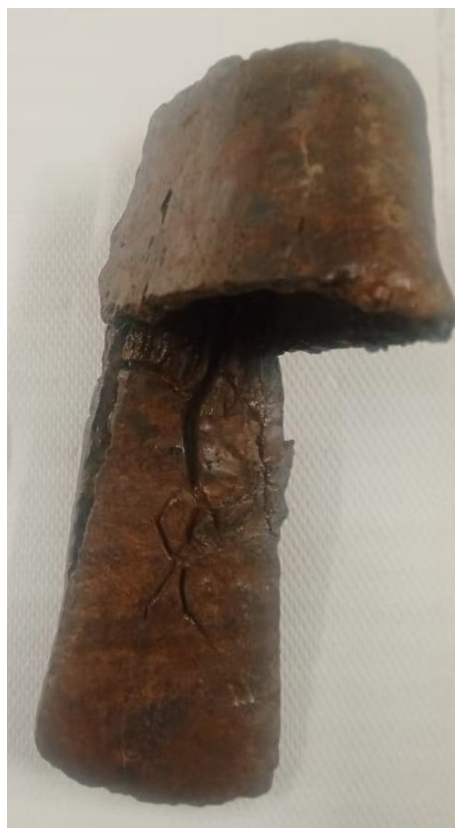
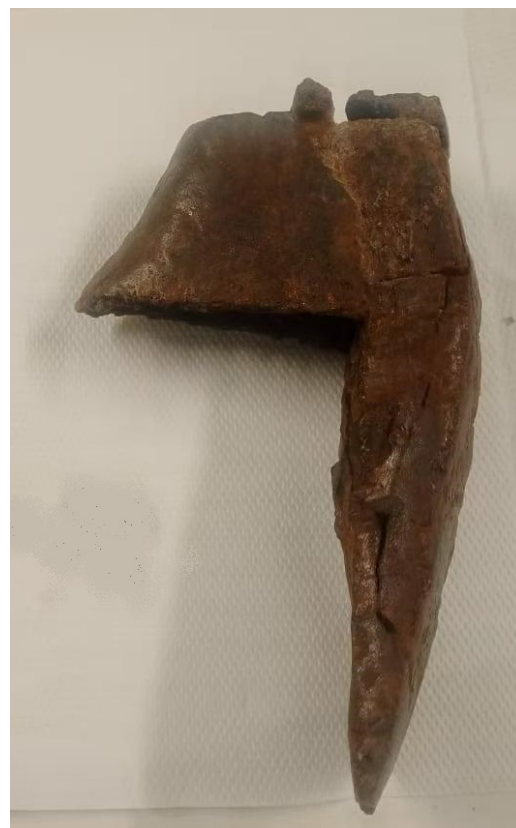
Bonding of the fragments of the sleeve from the later-damaged side (left) and the initially damaged side (right).

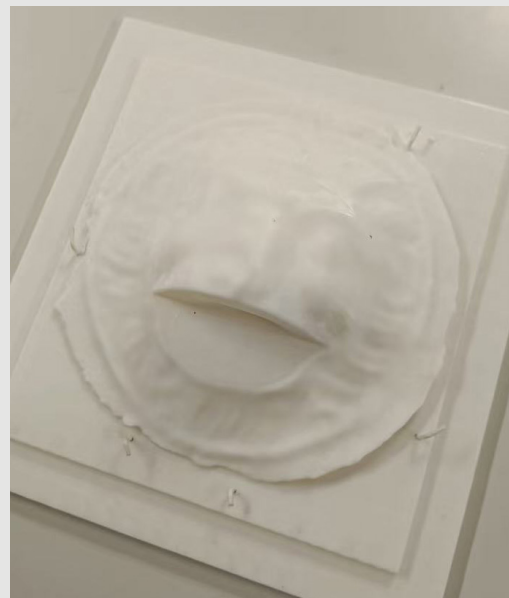
**Fig. 2**

Support of the lion-face handle realized through 3D techniques.
