# The Regional Center for Conservation and Restoration of Jerash, Jordan

editors Mario Micheli and Bilal Fawwaz Mohammad Alboreeni

This volume resulted from the project 'Creation of the Regional Center for Conservation and Restoration in Jerash', entrusted to Roma Tre University by the Italian Agency for Development Cooperation

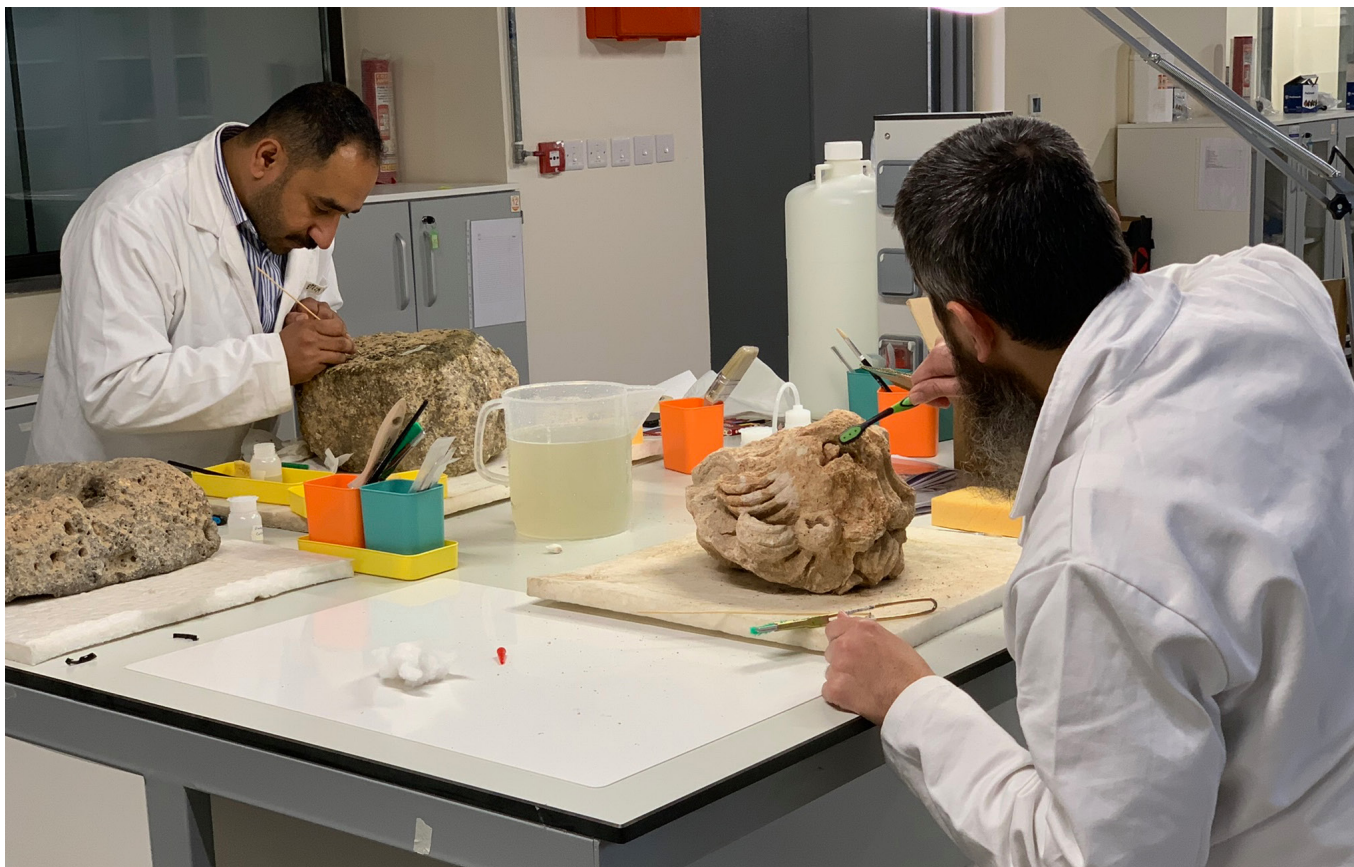
**Fig. 2**

Surface cleaning as a key stage in the conservation work.

Following careful initial graphic and photographic documentation, participants engaged with all stages of the restoration process: from cleaning – carried out using chemical, mechanical and laser methods (Fig. 2) – to the consolidation of structures through the application of advanced chemical treatments. The restoration of missing parts using specific mortars (Fig. 3) was also addressed, as was the reassembly of fragments using appropriate adhesives (Fig. 4). Finally, a final protective layer was applied to ensure the long-term preservation of the restored works, in accordance with safety and sustainability criteria.

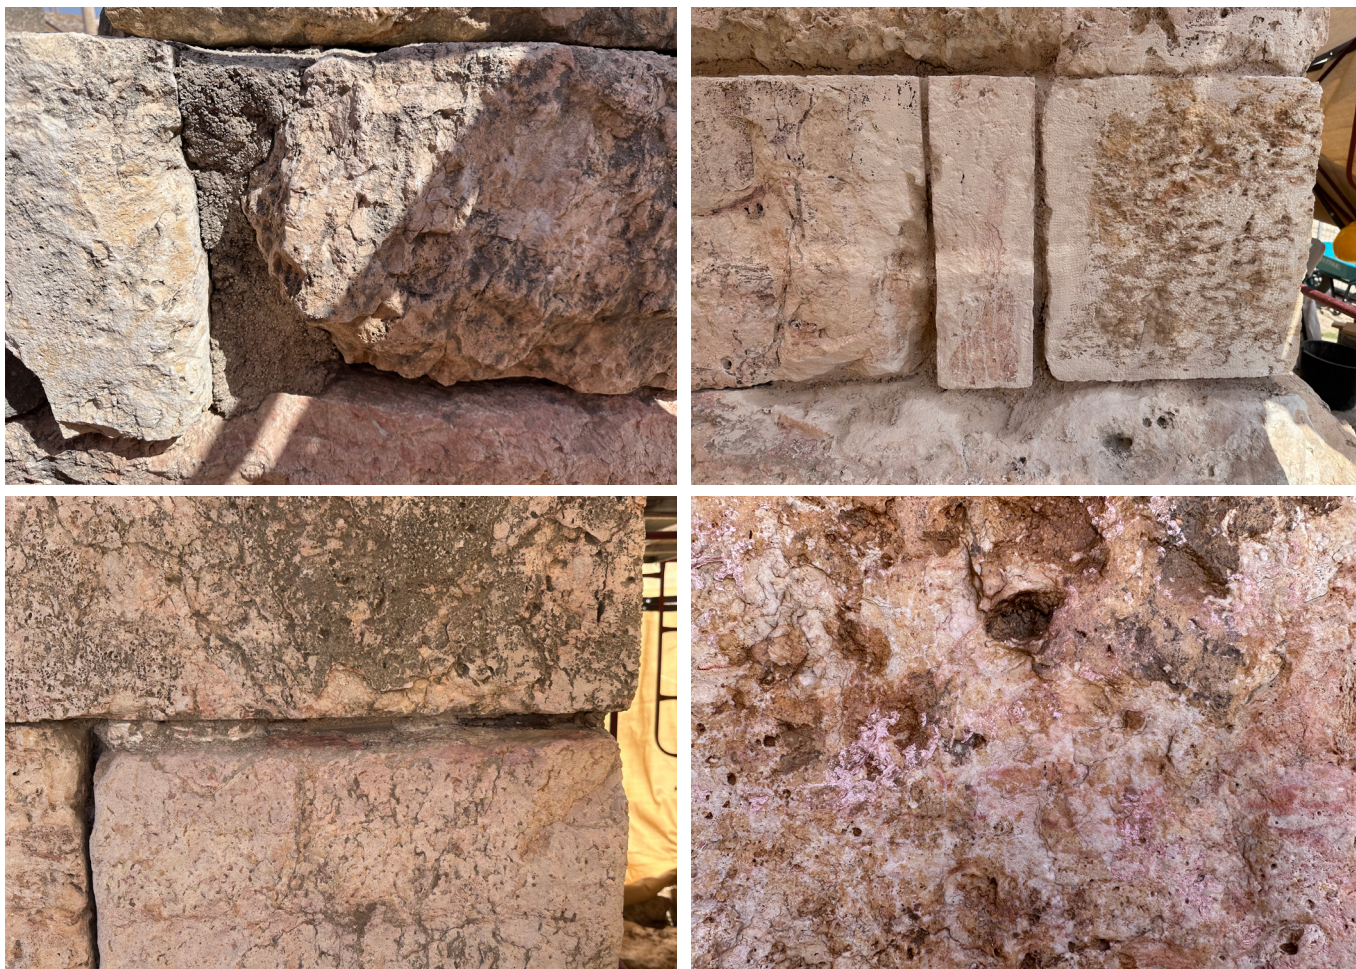
**Fig. 4**

Drill marks.

In certain areas, the use of a drill (Fig. 4) can also be observed. It was likely used to carve the floral motifs along the sides of the niche. This combination of tools is widely documented on monumental construction sites from the Roman era and reflects a highly specialised construction practice, capable of combining speed of work and efficiency.

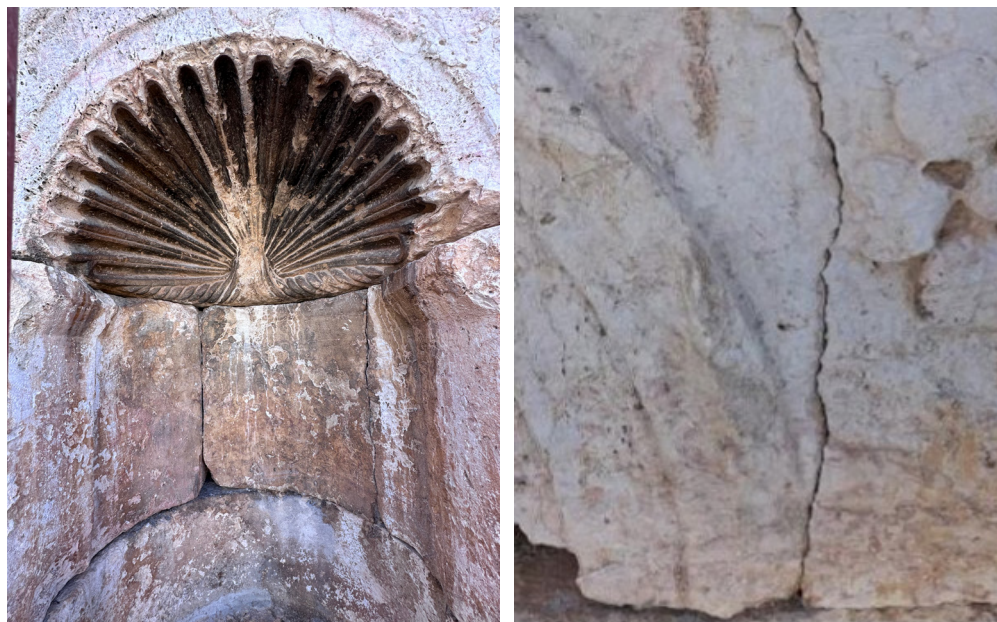
Cracking of the blocks.

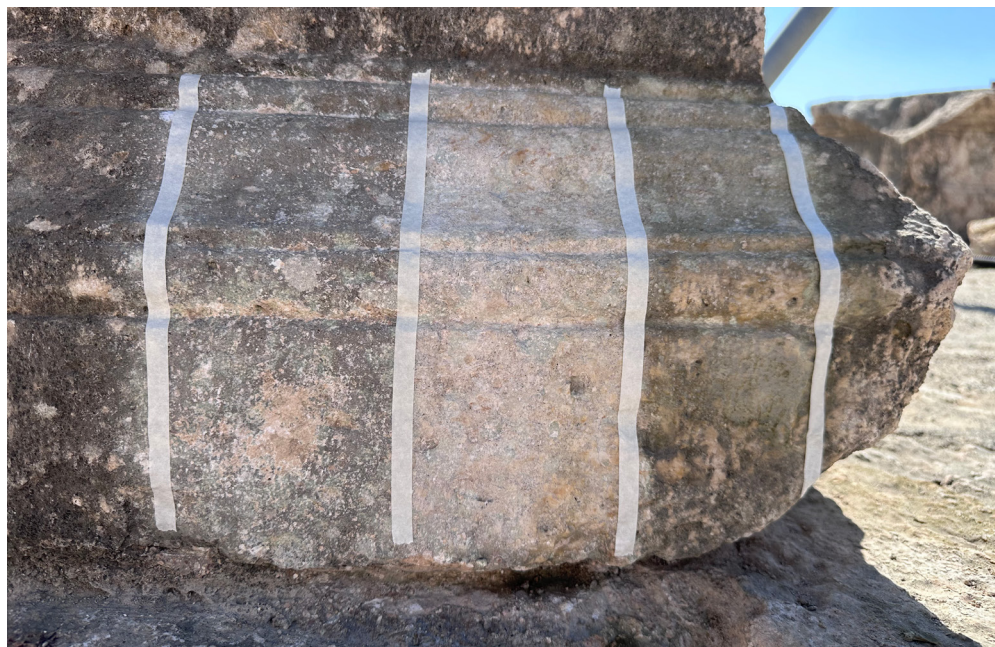
Cleaning test.

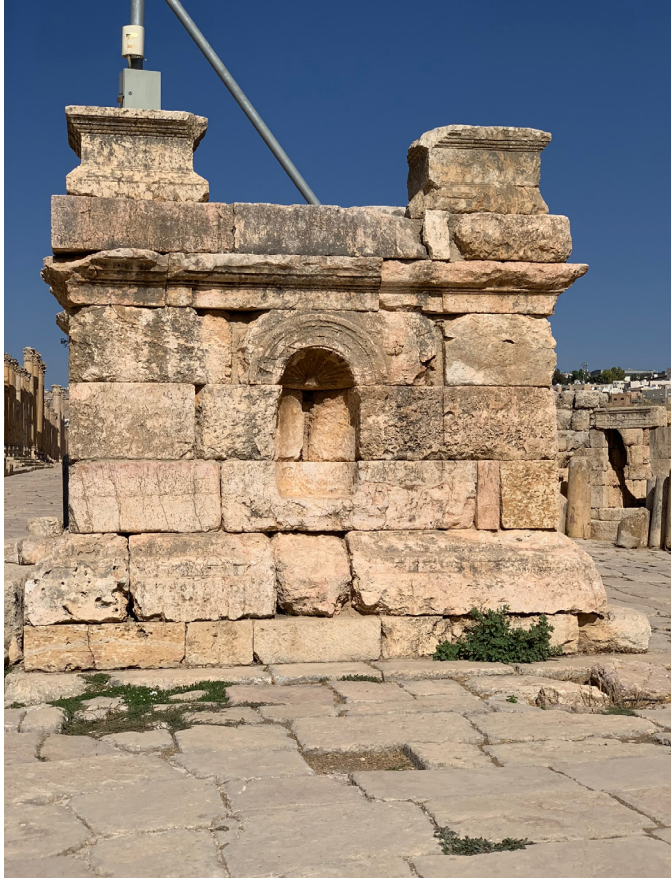
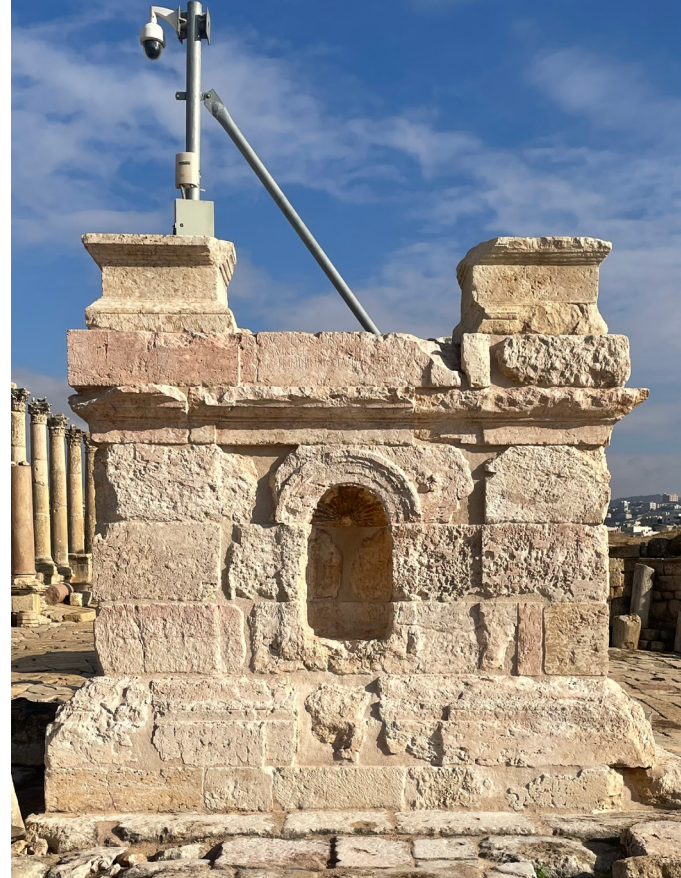
above, from left,  
**Fig. 22 a**  
South elevation of the  
monument before  
restoration.

**Fig. 22 b**  
South elevation of  
the monument after  
restoration.

The conservation and restoration work on the southern Tetrakionion successfully addressed the main conservation issues affecting in-situ stone heritage. These included the presence of incompatible modern materials, widespread biological colonisation, cohesive deposits accumulation in sheltered areas, and localised surface delamination. The selective removal of cement-based mortars, the treatment of oxidised metal inserts, and differentiated cleaning – mechanical, chemical and, where necessary, laser – based combined with consolidation and repointing using compatible mortars made of natural hydraulic lime, have re-established more balanced conservation conditions. Surface stability has been improved and the legibility of the architectural elements recovered, without resorting to invasive solutions.

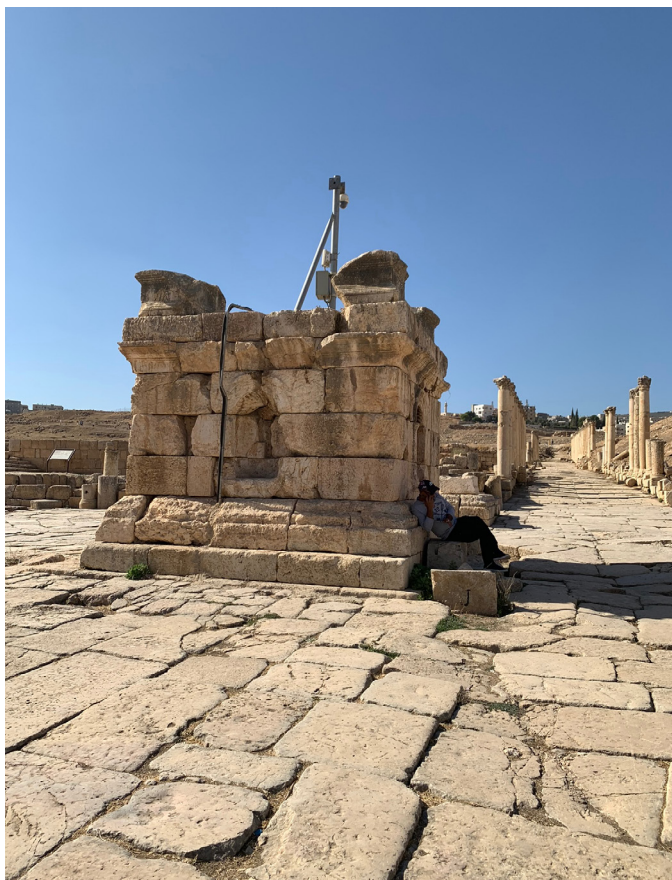
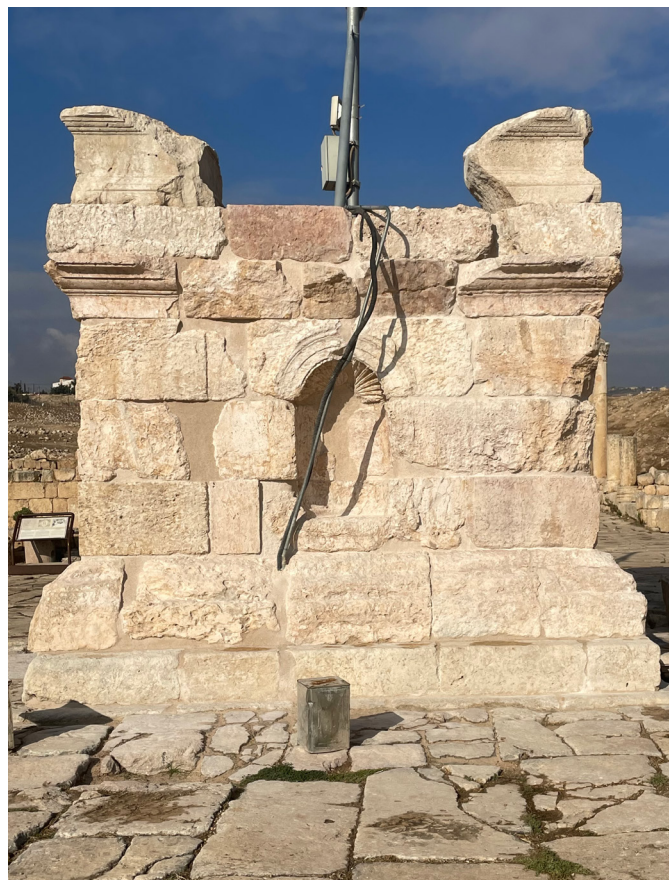
**Fig. 23 a**

East elevation of the monument before restoration.

East elevation of the monument after restoration.

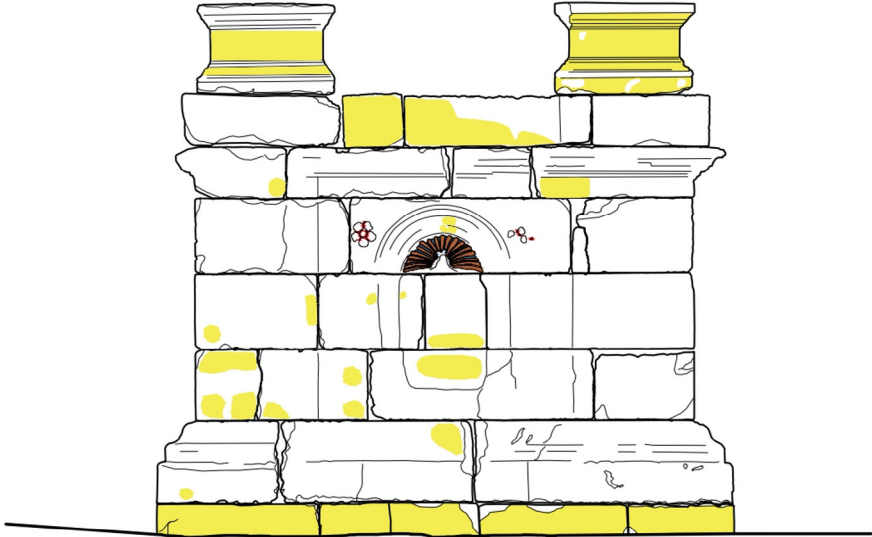
Table 2 - Tool traces

- Flat Chisel
- Tooth Chisel
- Drill
- Round Chisel

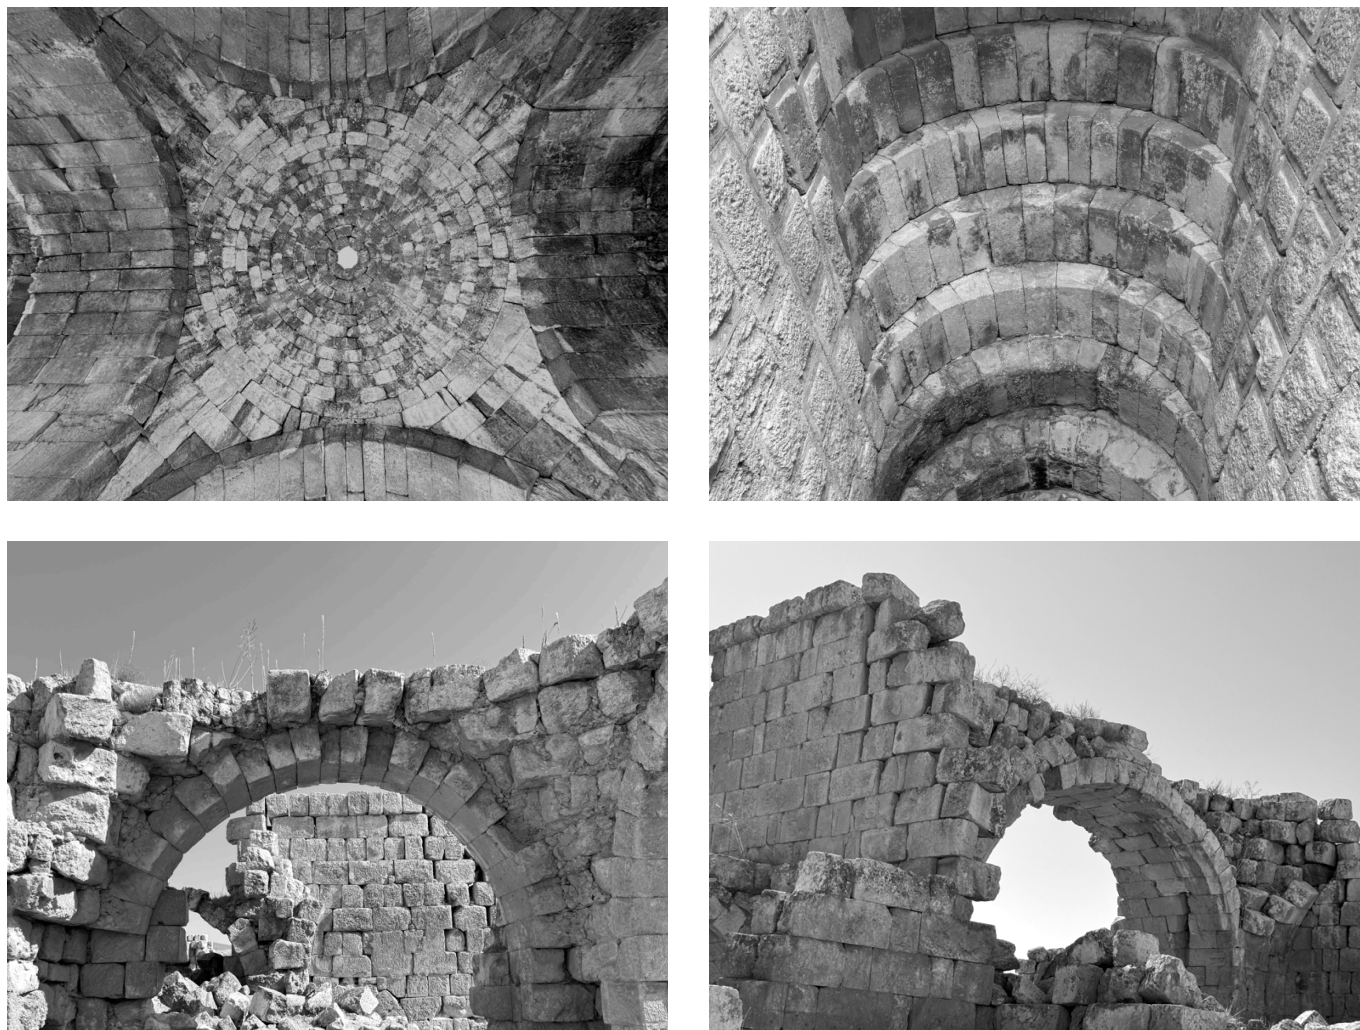
**Fig. 1**

The geometries of some stone structures and the severe damage conditions they have suffered.

The archaeological site of ancient Gerasa features a series of large structural systems made of stone blocks that have suffered severe damage due to earthquakes and lack of maintenance (Fig.1). The beauty of the archaeological site and the great structural challenge presented by many of the archaeological remains pose structural problems that cannot be addressed with traditional finite element analysis. In most cases, the structures consist of blocks that have undergone finite displacement, and the equilibrium condition is controlled primarily by the shape and position of the blocks and their displacement capacity, rather than by the stress state, as compared to the material strength. In this context, digital surveying of the stone skeleton and its reproduction in the structural analysis code, become the key factor for a reliable assessment of the safety level.

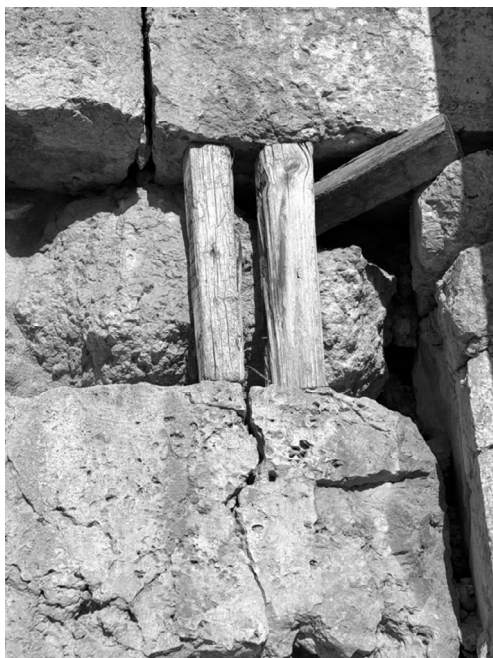
**Fig. 13**

Temporary stabilization measures for stone blocks using wooden trusses.

Four wooden struts were therefore installed to support two blocks that were in the most precarious condition. The beech wood props were connected by transverse wooden elements to stabilize the shoring system (Fig.13).

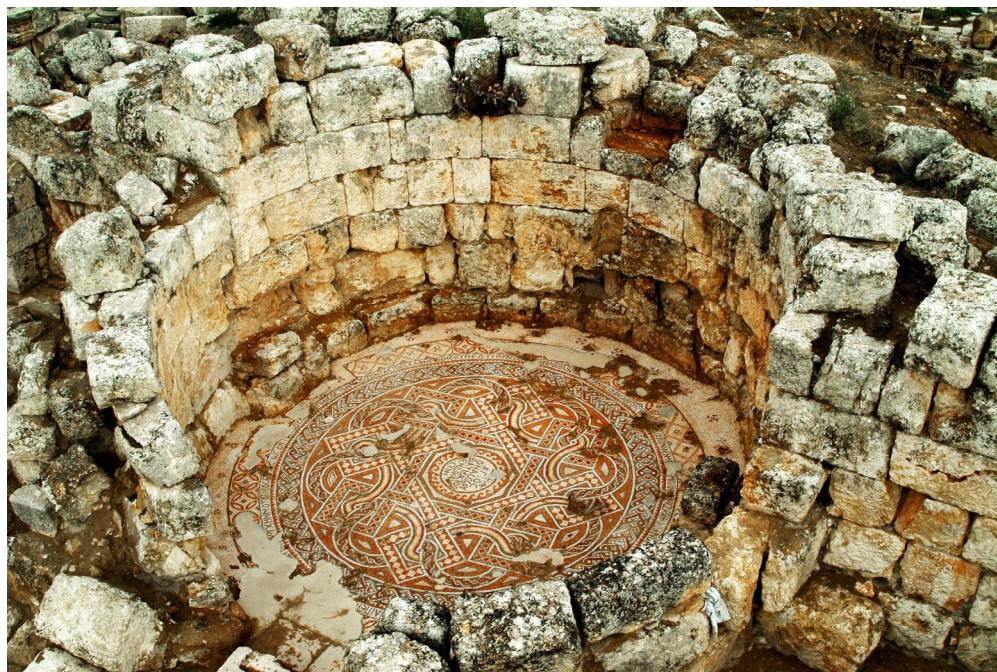
**Fig. 3**

Graphic survey of the Diaconia mosaic floor, illustrating the concentric arrangement of the pattern and the main gaps. © Piccirillo, 1993.

The floor consists of a circular mosaic, 6.5m in diameter, arranged in a strict geometric pattern based on radial symmetry and the alternation of borders and decorated fields, in accordance with the compositional principles of Late Antique geometric mosaics (Piccirillo, 1993; Dauphin, 1998) (Fig. 3).

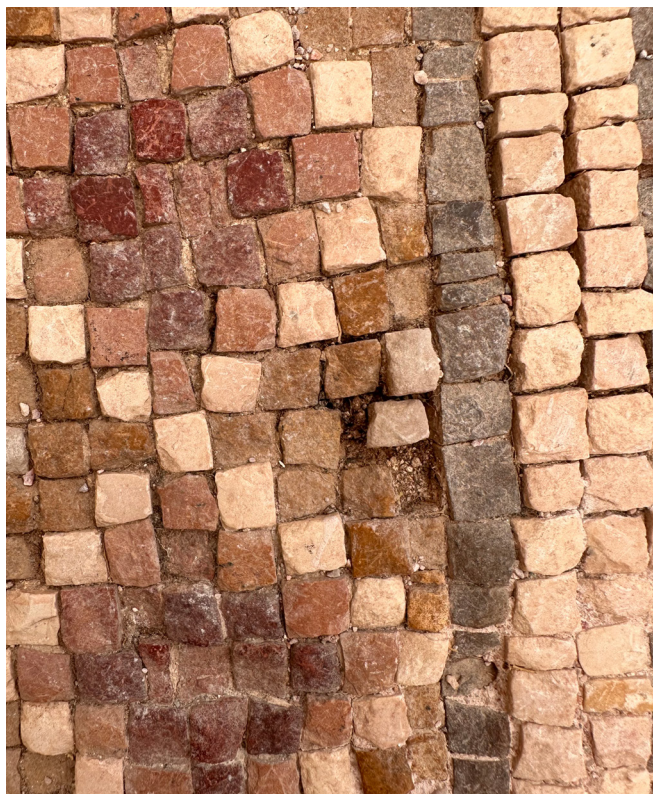
**Fig. 4**

Detail of the mosaic surface, showing the range of stone types and colours used in the decoration.

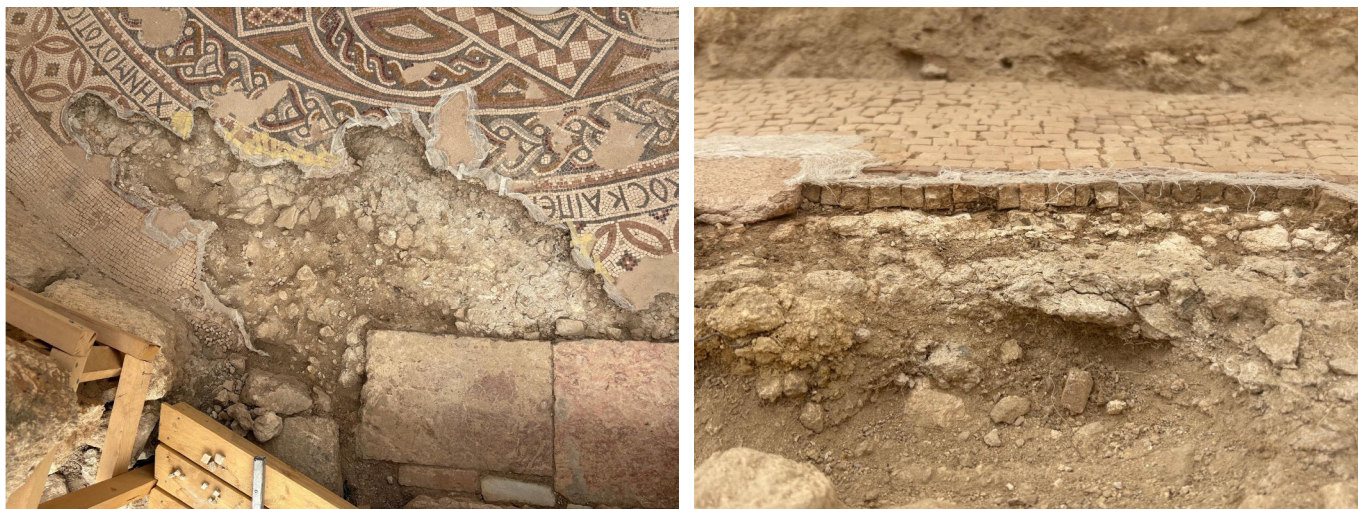
from left,  
**Fig. 5a**  
 view of the largest gap  
 located at the entrance to  
 the room.

**Fig. 5b**  
 Stratigraphic detail of  
 the gap showing the  
 sequence of layers  
 constituting the mosaic  
 floor (tesserae, bedding  
 mortar, preparatory layers).

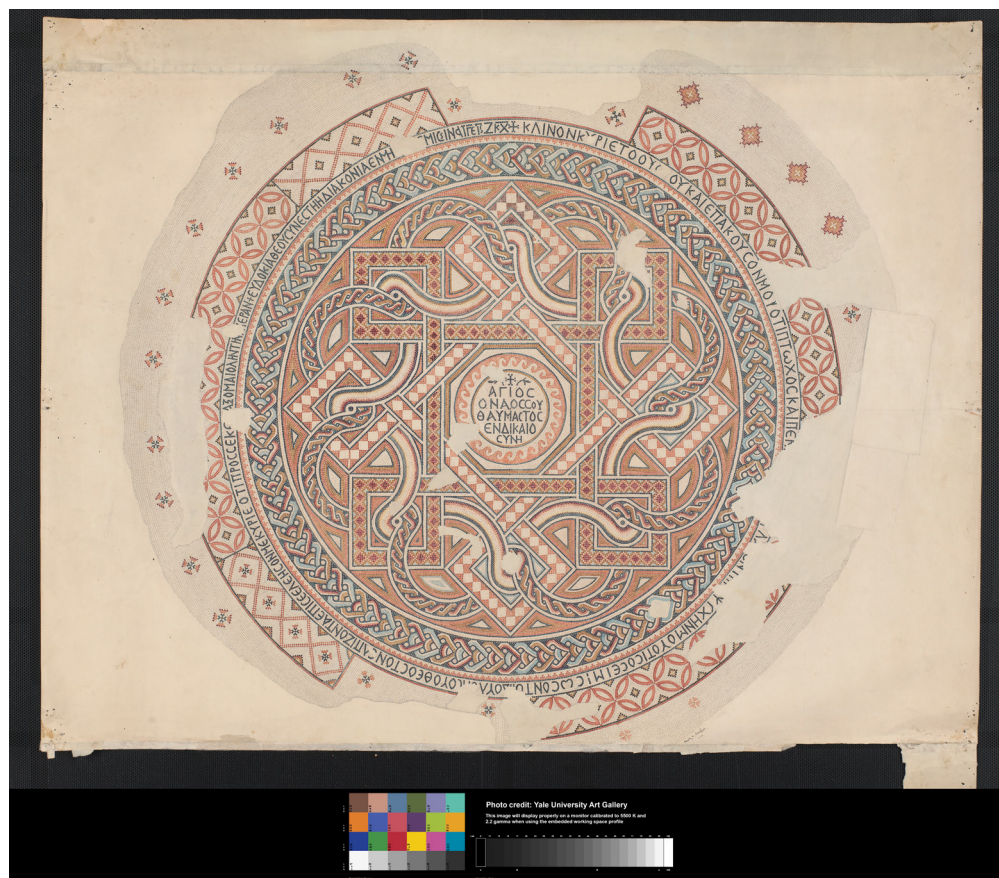
**Fig. 6**

Graphic reconstruction of the mosaic floor,  
produced in 1928–1929 by Dorothy Crowfoot  
Hodgkin.  
© Yale University Art Gallery.

An exceptionally important document for reconstructing the material history of the mosaic dates to this initial discovery: the graphic reconstruction made in 1928 by Dorothy Crowfoot Hodgkin (Fig. 6). The drawing, now preserved at the Yale University Art Gallery, depicts every single *tessera* at scale, reproducing with remarkable precision not only the pattern and colour scheme of the floor, but also the gaps already present at the time of discovery (Crowfoot Hodgkin, 1929-1930). This record may be regarded as a precursor to modern photogrammetry and represents the main reference for diachronic analysis of the mosaic's state of conservation (Crowfoot Hodgkin, 1929-1930). Comparison between Hodgkin's drawing and the mosaic's current state of conservation allows at least two major phases of restoration work to be distinguished. The gaps already visible in the 1920s-1930s correspond to areas now filled with grey cement-based grouting attributable to early 20th-century restoration works. These rigid, poorly compatible mortars were primarily aimed at restoring the physical continuity of the mosaic surface. By contrast, the more brittle, reddish fills observed in several areas are not documented in historical records and must therefore be attributed to later damage, likely resulting from prolonged exposure, repeated cycles of uncovering and covering, and the lack of systematic maintenance.

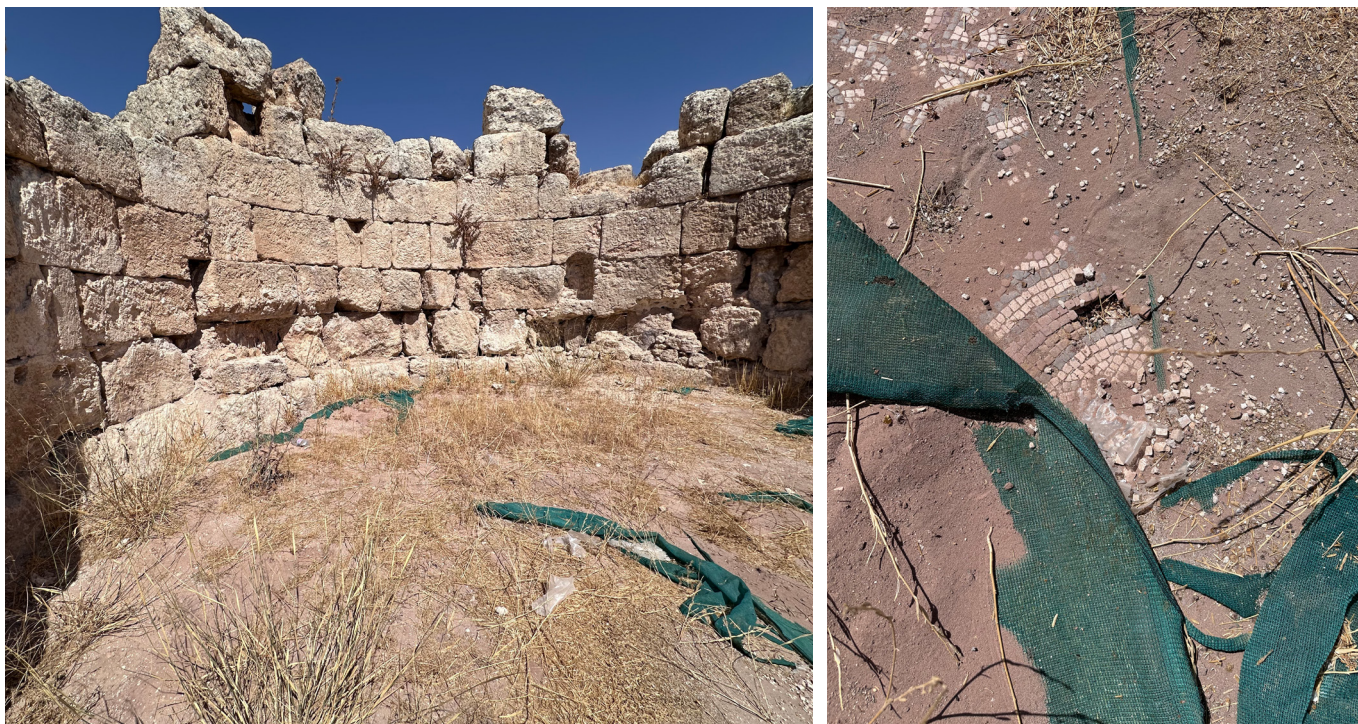
**Fig. 7a**

State of conservation of the mosaic prior to full uncovering: the surface is partially covered by an inadequate protective system consisting of a synthetic fibre sheet and a layer of sand. Vegetation growing through the covering is visible.

the preliminary operations had been completed, conservation work began with the controlled removal of the protective covering, consisting of – as stated above – a sand layer and a tightly woven synthetic fibre mesh. Vegetation emerging through the mesh was first cut back, and then the overlying sand was gradually removed (Fig. 13). This operation was carried out systematically, with the sand being collected and sieved to recover any loose *tesserae*. During the documentation phase, the mosaic surface had been divided into functional areas to allow for precise localisation of the detached *tesserae*. The recovered *tesserae* were therefore collected, catalogued and stored in bags labelled according to the division scheme. Following the removal of the covering layers, residual sandy deposits beneath the mesh were carefully removed manually using soft-bristled brushes, with particular attention paid to avoiding mechanical stress on the mosaic surface (Fig. 14). The removed material was again systematically sieved, allowing for the complete recovery of detached *tesserae*, which were subsequently arranged according to their area of origin. This phase revealed a critical state of conservation of the white perimeter band, characterised by numerous dislodged *tesserae* and the formation of new gaps. Temporary edge and gaps protection was therefore applied using a mortar made from local sand and air lime, ensuring the stability of the mosaic during subsequent stages.

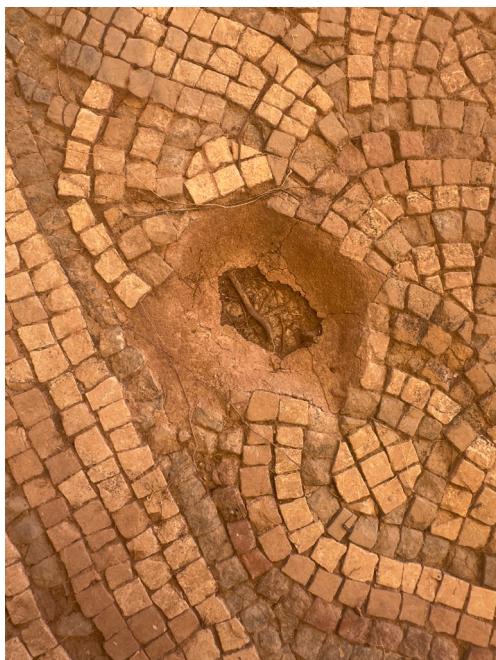
**Fig. 11**

The mosaic surface itself was, overall, in a reasonably good state of conservation. However, at the time of uncovering, it was covered by a widespread deposit of loose material accumulated on the mosaic as a result of the inadequate protection system. The interstitial mortar was also almost entirely absent, most likely because of the mosaic's conservation history in particular, previous cleaning operations carried out using excessively aggressive methods (Fig. 9a). Subsequent cleaning revealed further conservation issues affecting the newly exposed *tesserae*. In the northern section of the floor, an area characterised by irregular and poorly defined boundaries exhibited severe bleaching, marked colour alteration and surface erosion (Fig. 9b). This evidence supports the hypothesis of a previous chemical cleaning treatment, likely involving acidic agents, as already discussed in the conservation history. Microscopic observations and analyses carried out on the *tesserae* by the Interdepartmental Laboratory of Electron Microscopy at Roma Tre University appear to confirm this hypothesis (see also E. Rossi, M. C. Caggiani, 'Application of SEM-EDS to the analysis of a mosaic *tessera* and a glazed ceramic from Jerash', in this volume). Particularly problematic were the grouting works associated with earlier restoration campaigns. Those dating to the first half of the 20th century were executed using cement-based mortars, characterised by high rigidity and marked physical and chemical incompatibility with the original materials. These additions were visually intrusive and, in some areas – especially along the edges of gaps – protruded onto the surface of the *tesserae*. In other cases, they had even been used as interstitial mortar (Figs. 10 a, b). Later restoration works, likely carried out in the early 21st century, employed fewer rigid materials than cement-based mortars. However, these too had undergone degradation and alteration, both in aesthetic terms and from a conservation perspective (Fig. 11).

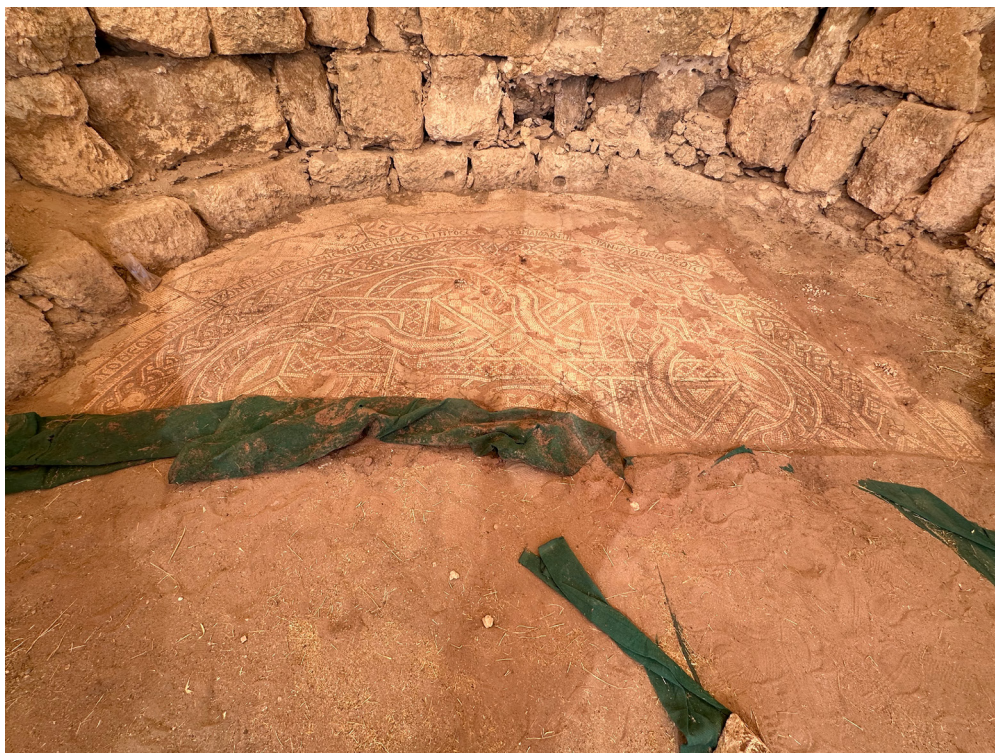
**Fig. 13**

General view of the mosaic within the apse prior to restoration, with part of the protective covering still in place and accumulations of surface deposits.

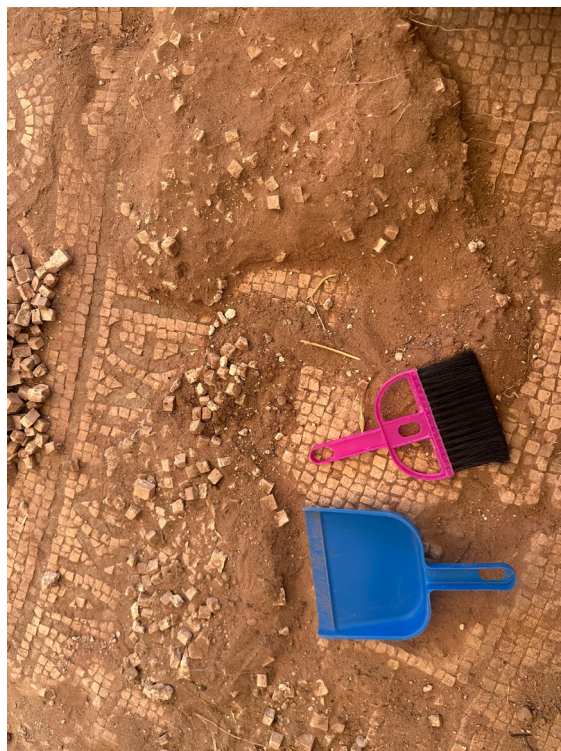
Controlled removal of the covering and loose deposits using manual tools (brushes and trowels), aimed at recovering dislodged tesserae and securing the surface.

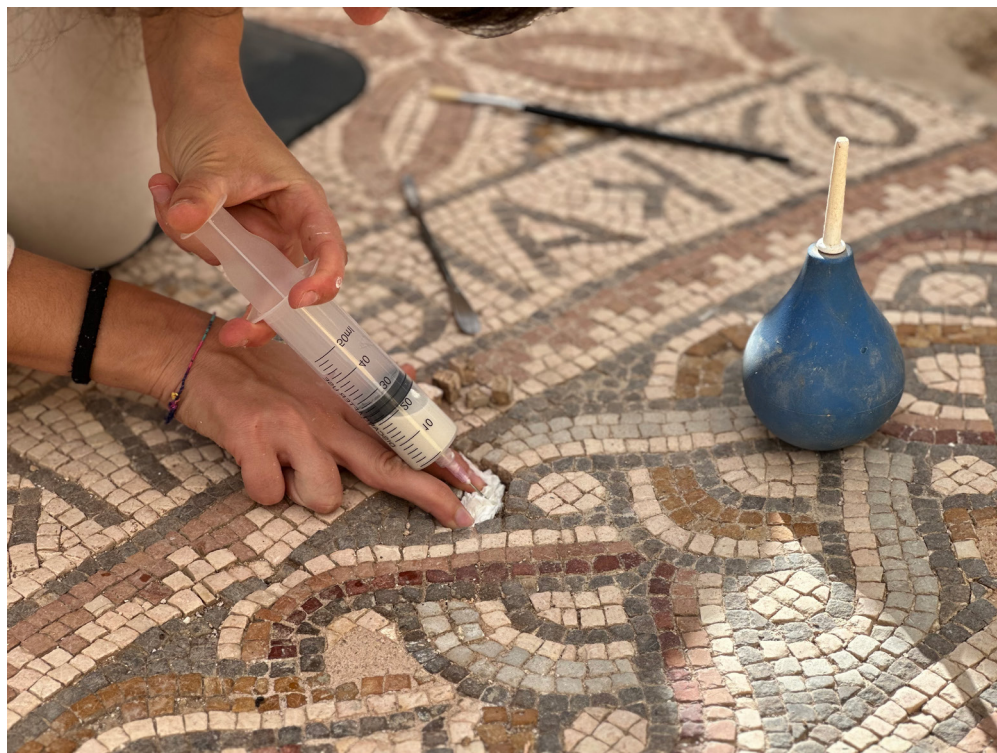
**Fig. 16**

by localised deep consolidation aimed at re-establishing adhesion between the *tessellatum* and the underlying layers, through injections of a suitable mortar (Ledan ITAL TB2®) (Fig. 16).

Localised consolidation carried out by injecting a consolidant using a syringe.

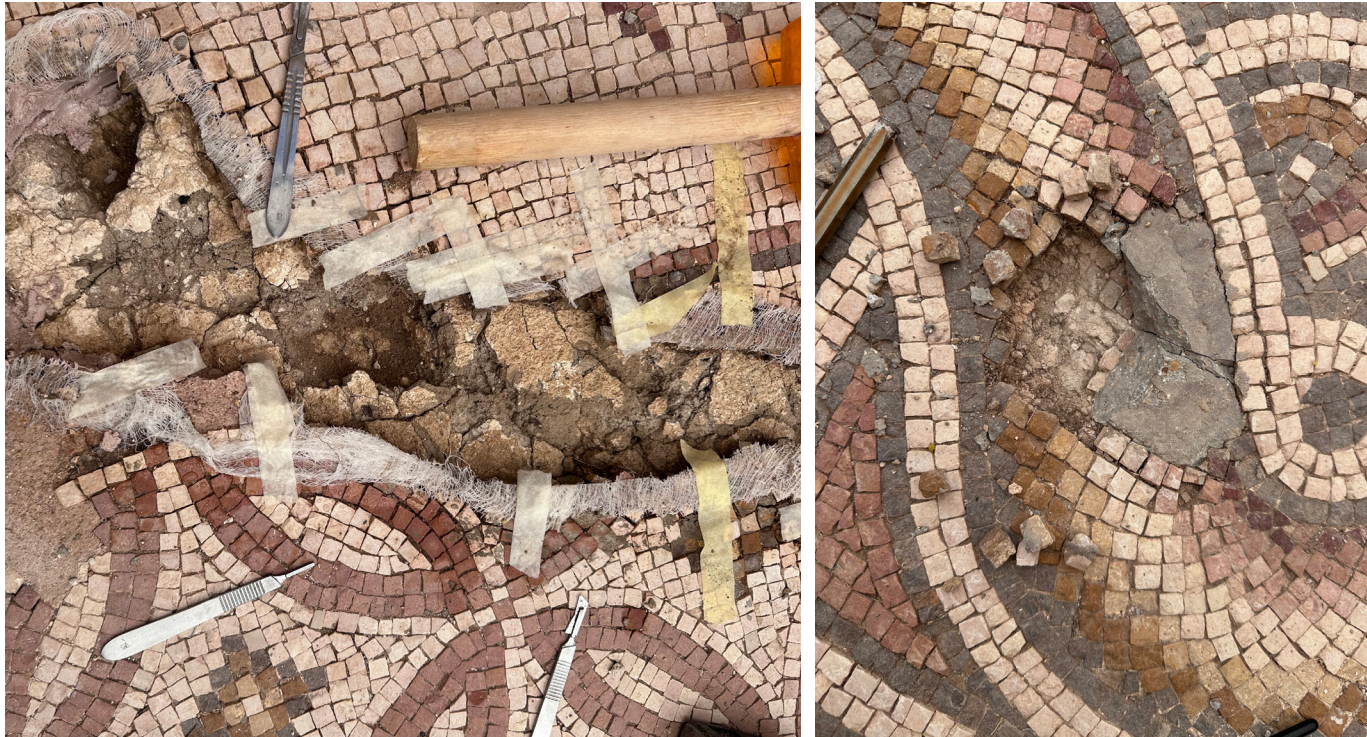
**Fig. 18**

To prevent prolonged exposure of the *lacunae* and the consequent risk of detachment of adjacent *tesserae*, temporary layered grouting was applied during the removal work. It consisted of two layers: a roughcast of air lime and coarsely sieved local aggregates (ratio 1:3), followed by a finer layer of air lime and more finely sieved aggregates (ratio 1:2) (Fig. 18). At the same time, after removing the protective facing from the edges using acetone compresses, excess cement protruding onto the *tesserae* was mechanically removed using ultrasonic devices and rotary micro-tools (Fig. 19).

Gap stabilised with a temporary mortar to secure tesserae during subsequent intervention phases.

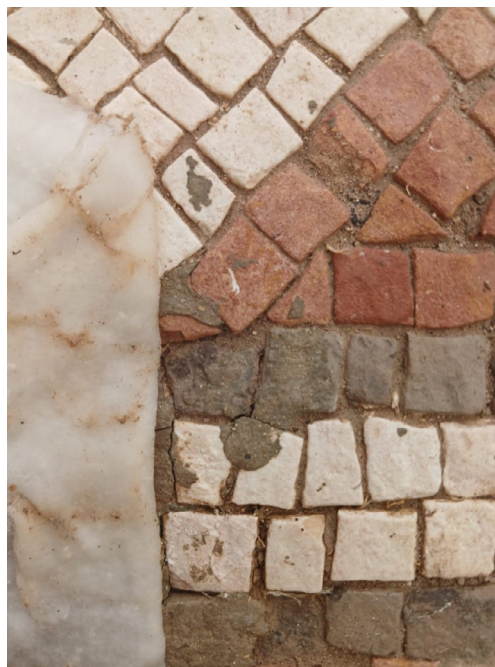
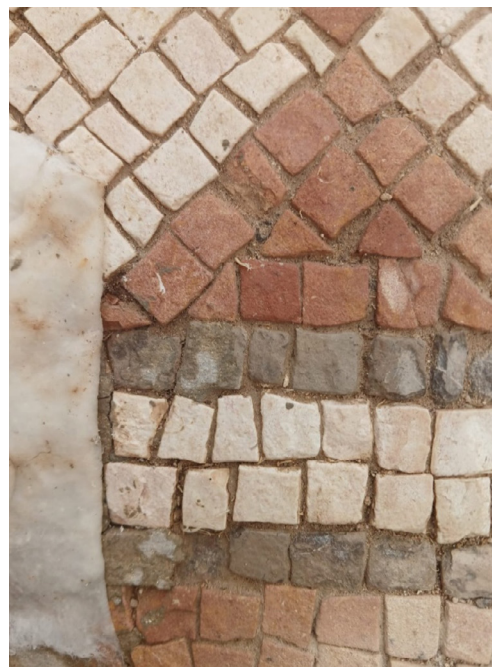
hydroxide dispersed in ethanol (Calosil E25®) (Fig. 20). The large gap near the entrance, extending through the entire stratigraphy down to the subsoil, required preliminary consolidation of the earthen substrate. This was achieved by applying an injection mortar highly diluted in water (Ledan ITAL TB2®) using a brush, to ensure the stability of the subsequent layers of roughcast and grouting.

**Fig. 20**  
Large gap characterised  
by the loss of *tesserae*,  
where the bedding  
layer and imprints of  
the original *tesserae* are  
visible.

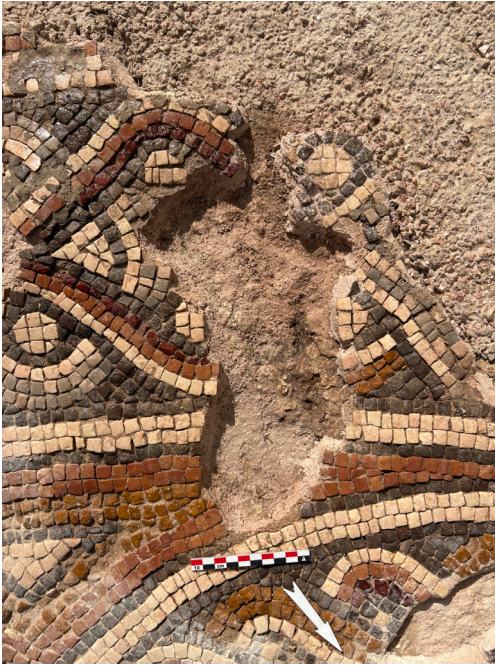
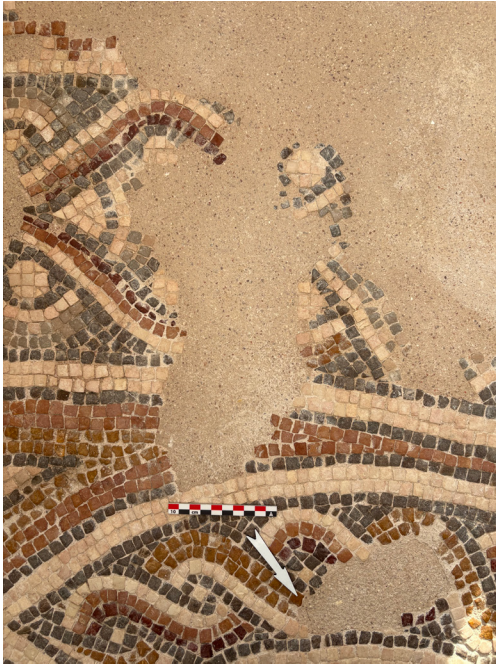
In the final stages of the restoration work, the treatment of gaps was guided by a critical assessment of grouting depth and extent. For reasons of conservation and visual consistency, all gaps were filled using the same method, maintaining a slight recess of approximately 1mm below the surface of the mosaic. This solution makes it easier to remove surface deposits and facilitates future maintenance, particularly in view of the mosaic's public display. An exception was made for a small gap near the entrance, which was intentionally left open to expose the *sovranucleus*, which preserves the imprints of the original *tesserae*. For similar conservation reasons and again to facilitate future maintenance of the mosaic, an interstitial mortar – which the diagnostic phase had shown to be almost absent – was also applied across the entire surface to restore cohesion of the mosaic surface.

The final grouting was therefore carried out in two layers. The first, a roughcast layer, was based on hydraulic lime and coarsely sieved aggregates (ratio 1:3). The second, a thin surface layer, was based on air lime and selected aggregates (ratio 1:2): one part lime putty to two parts aggregates, the latter being a mixture of local sieved sand and sieved travertine in a 2:1 ratio. The mortar pattern was defined through preliminary testing (Figs. 21a, b). At the same time, the interstitial mortar was applied using the same mortar based on air lime as that used for the final layer, ensuring consistency in terms of material properties, colour and overall work execution.

**Figs. 21a-b**  
Before and after the  
application of the final  
mortar on the gaps.

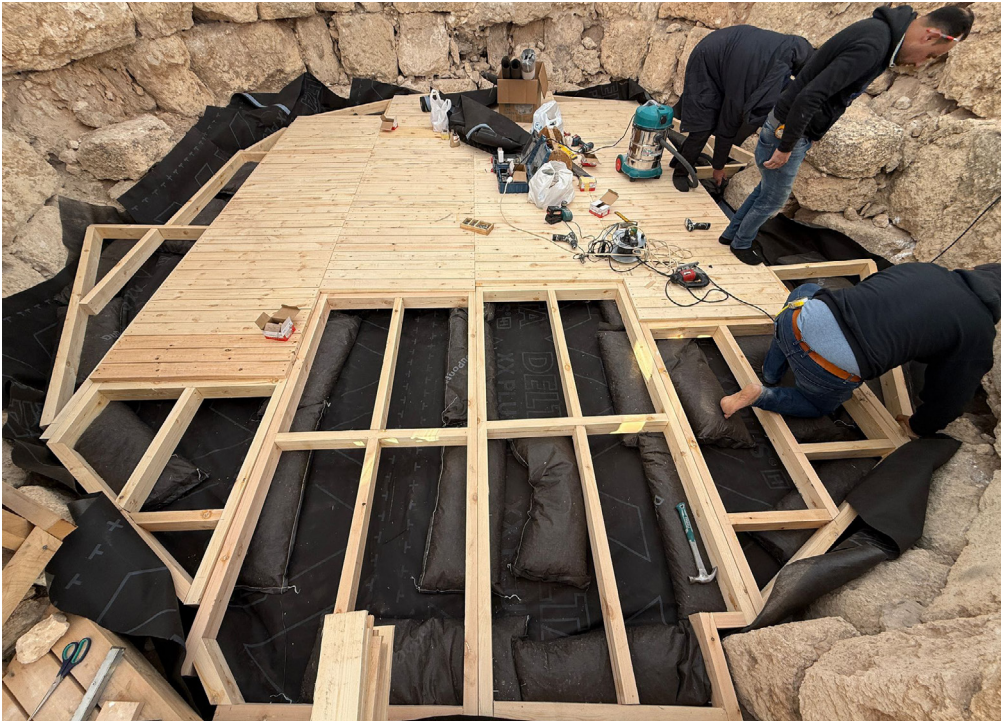
**Fig. 23a**  
Installation of the  
suspended wooden  
flooring system.

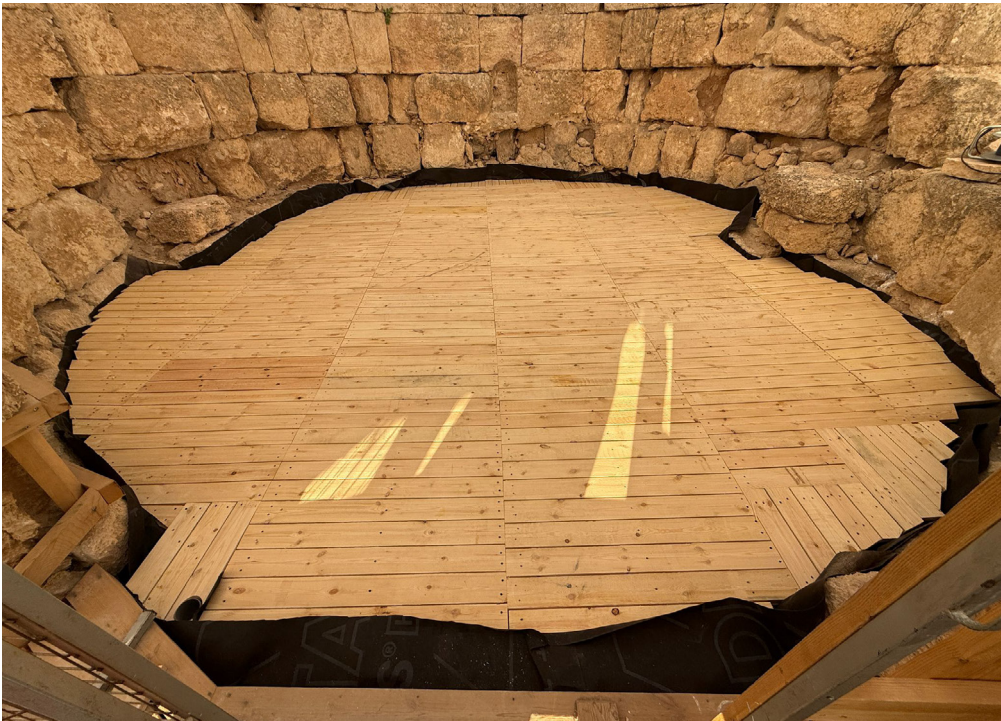
**Fig. 23b**  
Completed wooden  
walkway. Reversible  
modular structure  
designed to protect  
the mosaic and allow  
controlled access.

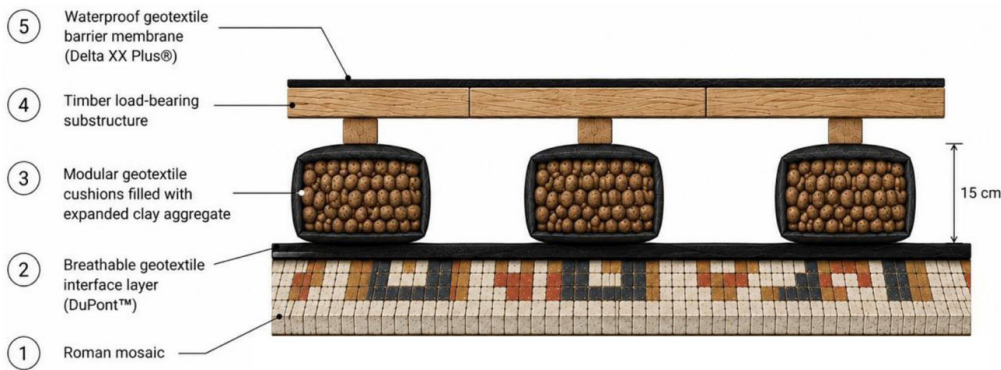
**Fig. 23b**  
Stratigraphic section of  
the protective covering  
system.
