# The Regional Center for Conservation and Restoration of Jerash, Jordan

editors Mario Micheli and Bilal Fawwaz Mohammad Alboreeni

This volume resulted from the project 'Creation of the Regional Center for Conservation and Restoration in Jerash', entrusted to Roma Tre University by the Italian Agency for Development Cooperation

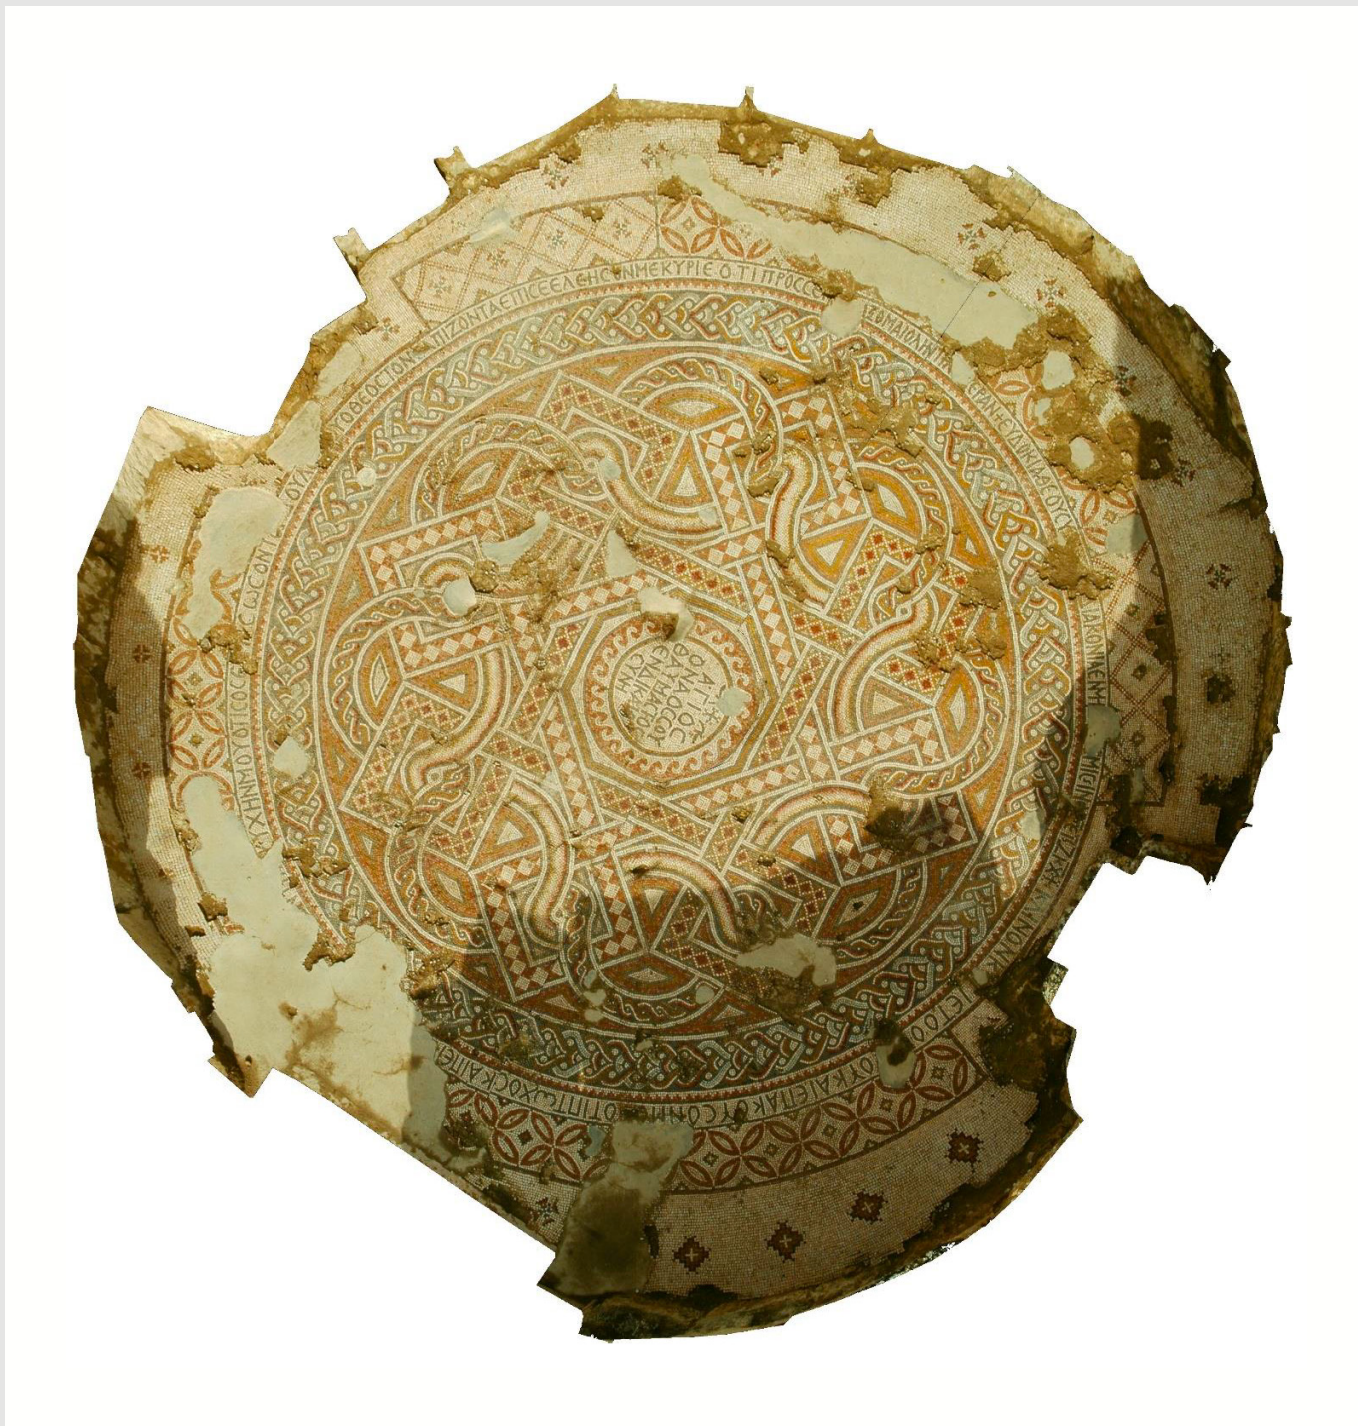
Fig. 1

Diaconia Mosaic, Church of the Propylaea. Rectified photograph, 2004. After M. Brizzi, 2021.

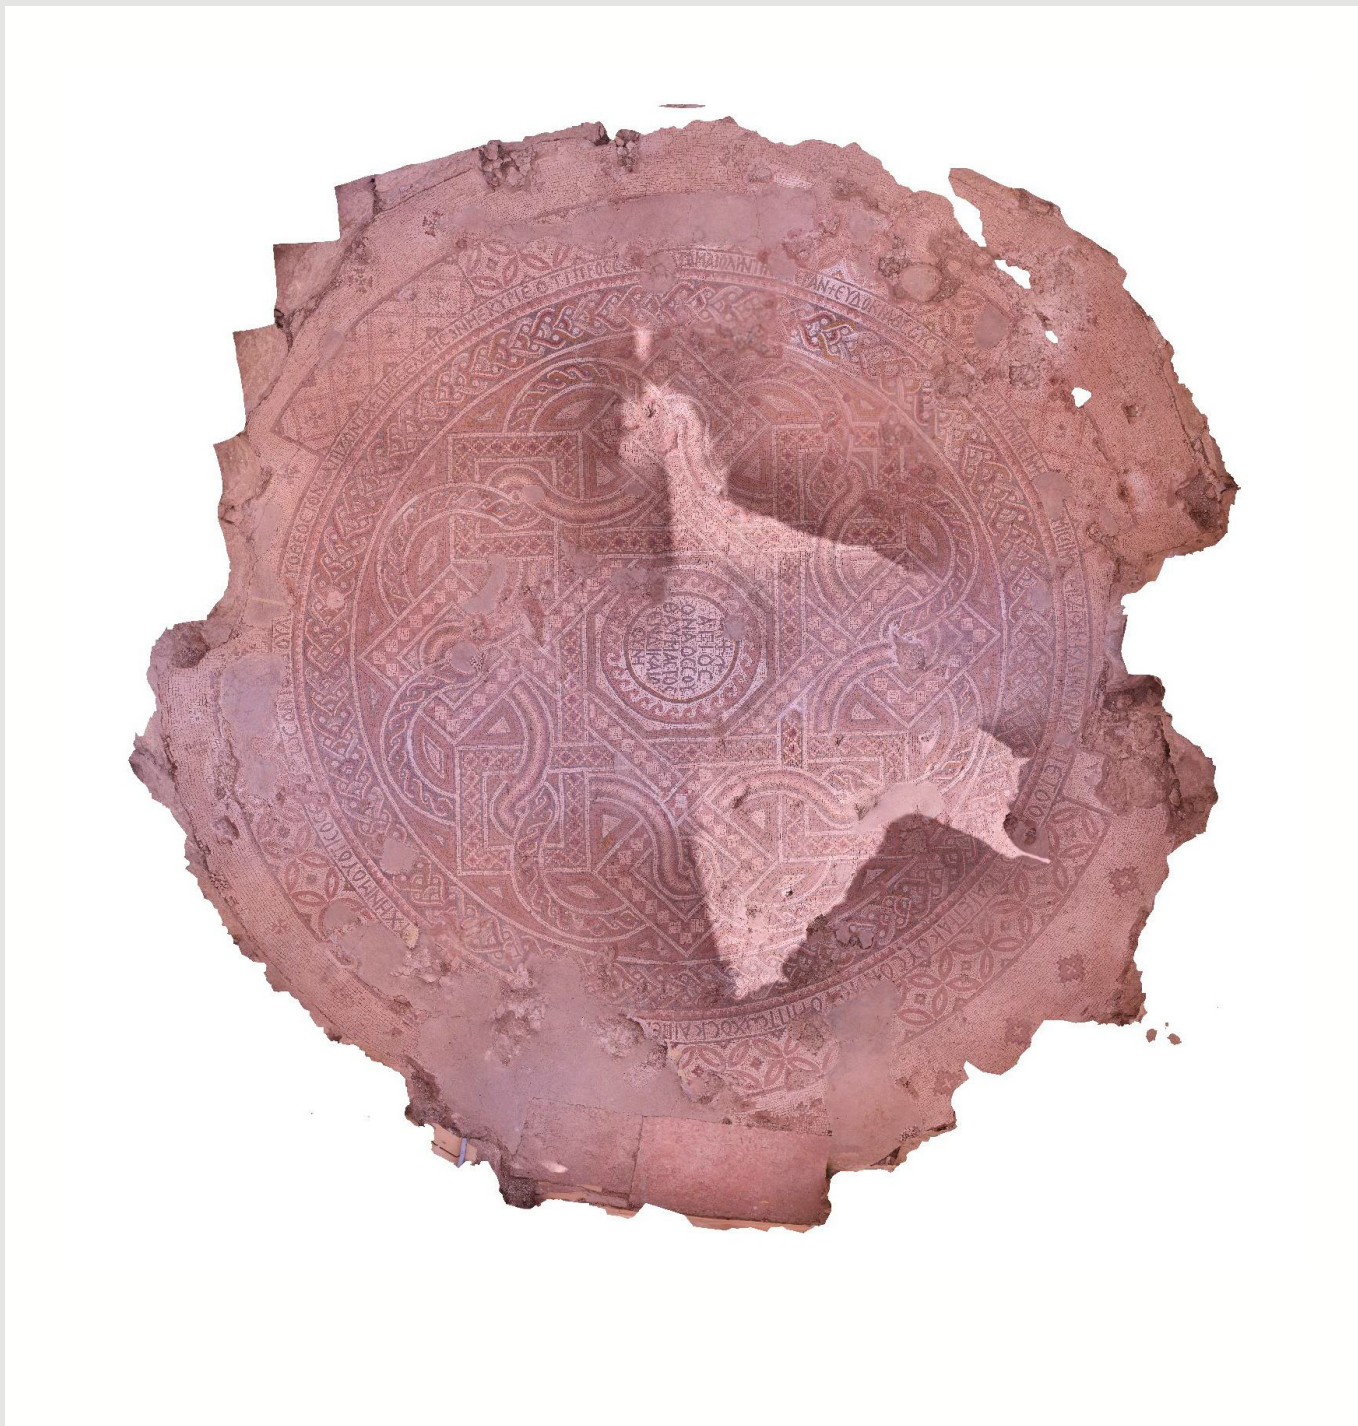
Following the exposure of the mosaic, a series of overlapping photos were taken before starting the work to document the mosaic floor after remove the cover (Fig. 3) a systematic documentation and condition assessment process was undertaken. This assessment was structured through five dedicated documentation tables (Fig. 4) addressing: Table 1 (Materials), Table 2 (Previous Interventions), Table 3 (Conditions), and Table 4 (Treatment), and Table 5 (Samples). All observations were recorded in a Condition assessment map (Fig. 5) in accordance with a standardized Legend to ensure clarity, consistency, and methodological coherence (deterioration, plants intrusion, tesserae loss, lacunae, detachment, depression and rise).

**Fig. 3**  
Rectified orthophoto (before the conservation treatment), 2025.

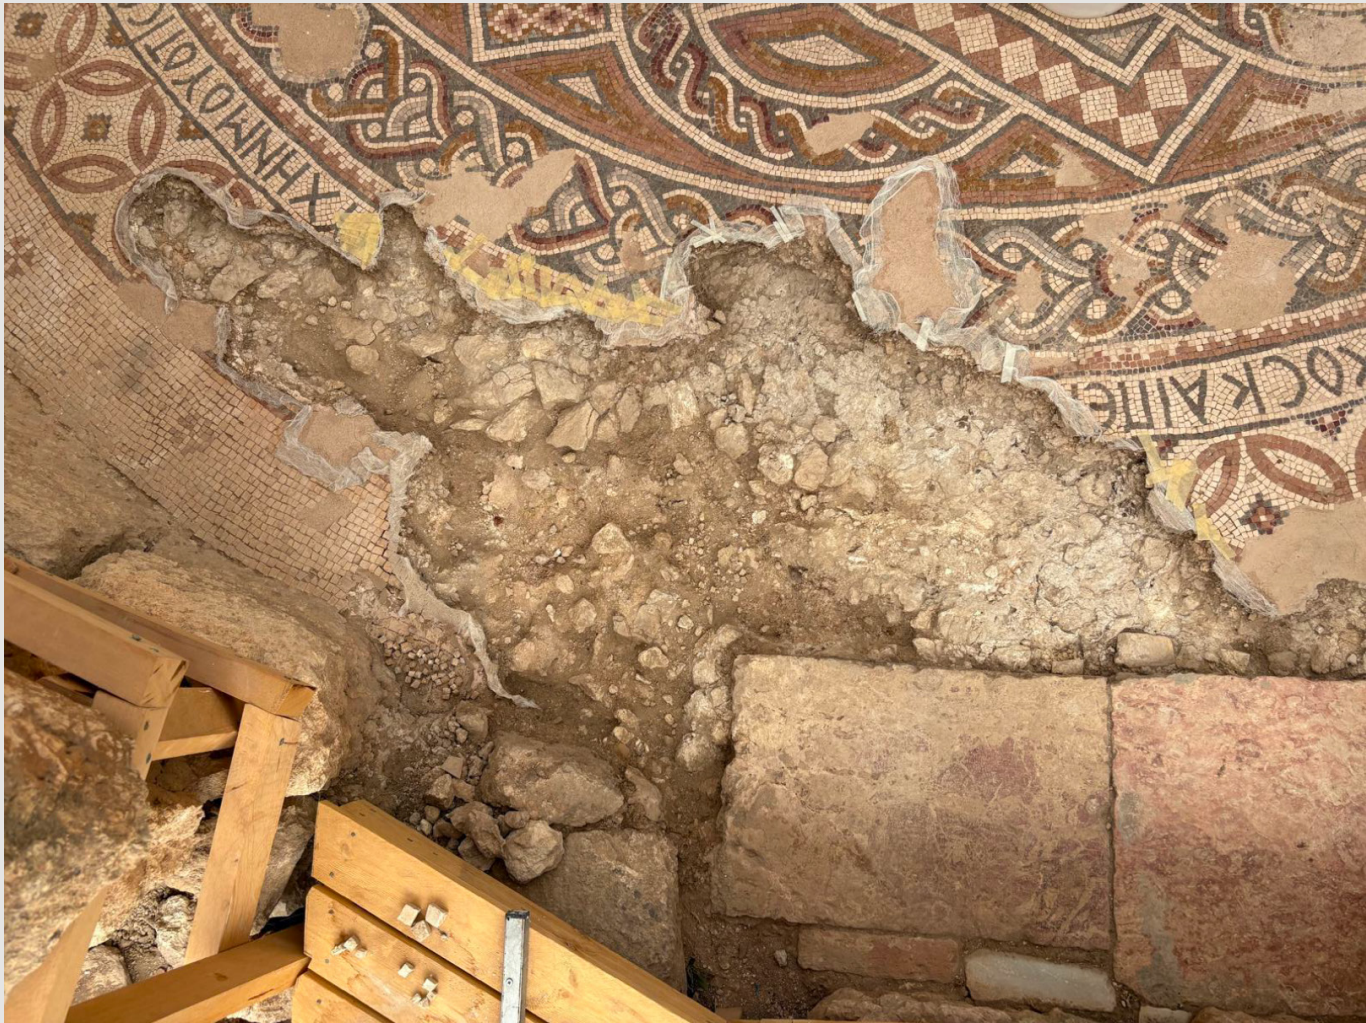
**Fig. 6**

Top view of the original stratigraphic layers.

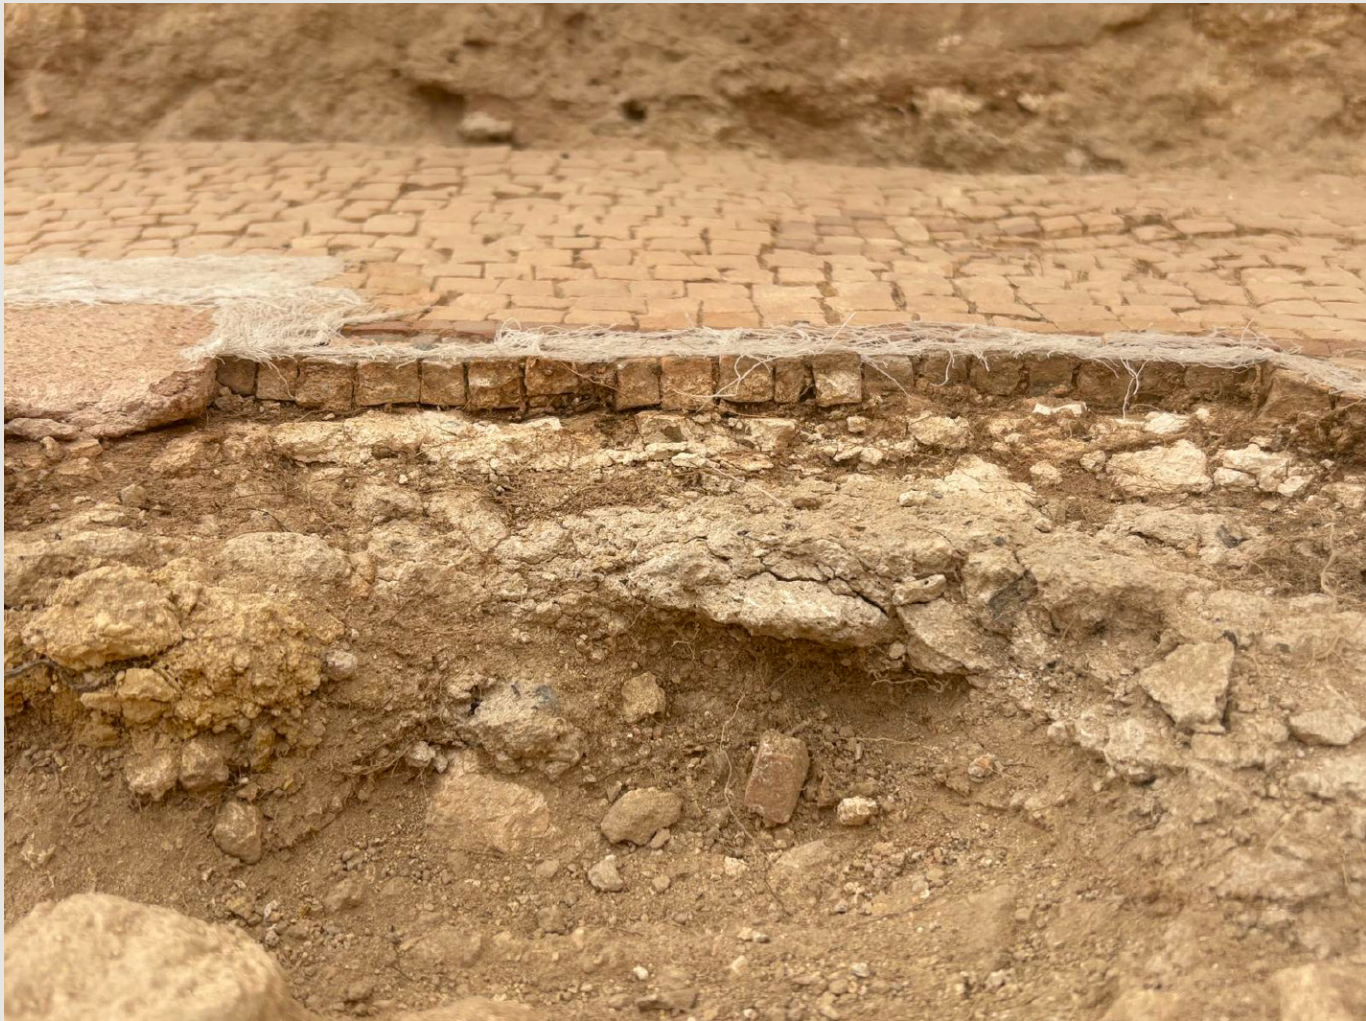
**Fig. 7**

Section A-A of the original stratigraphic layers.

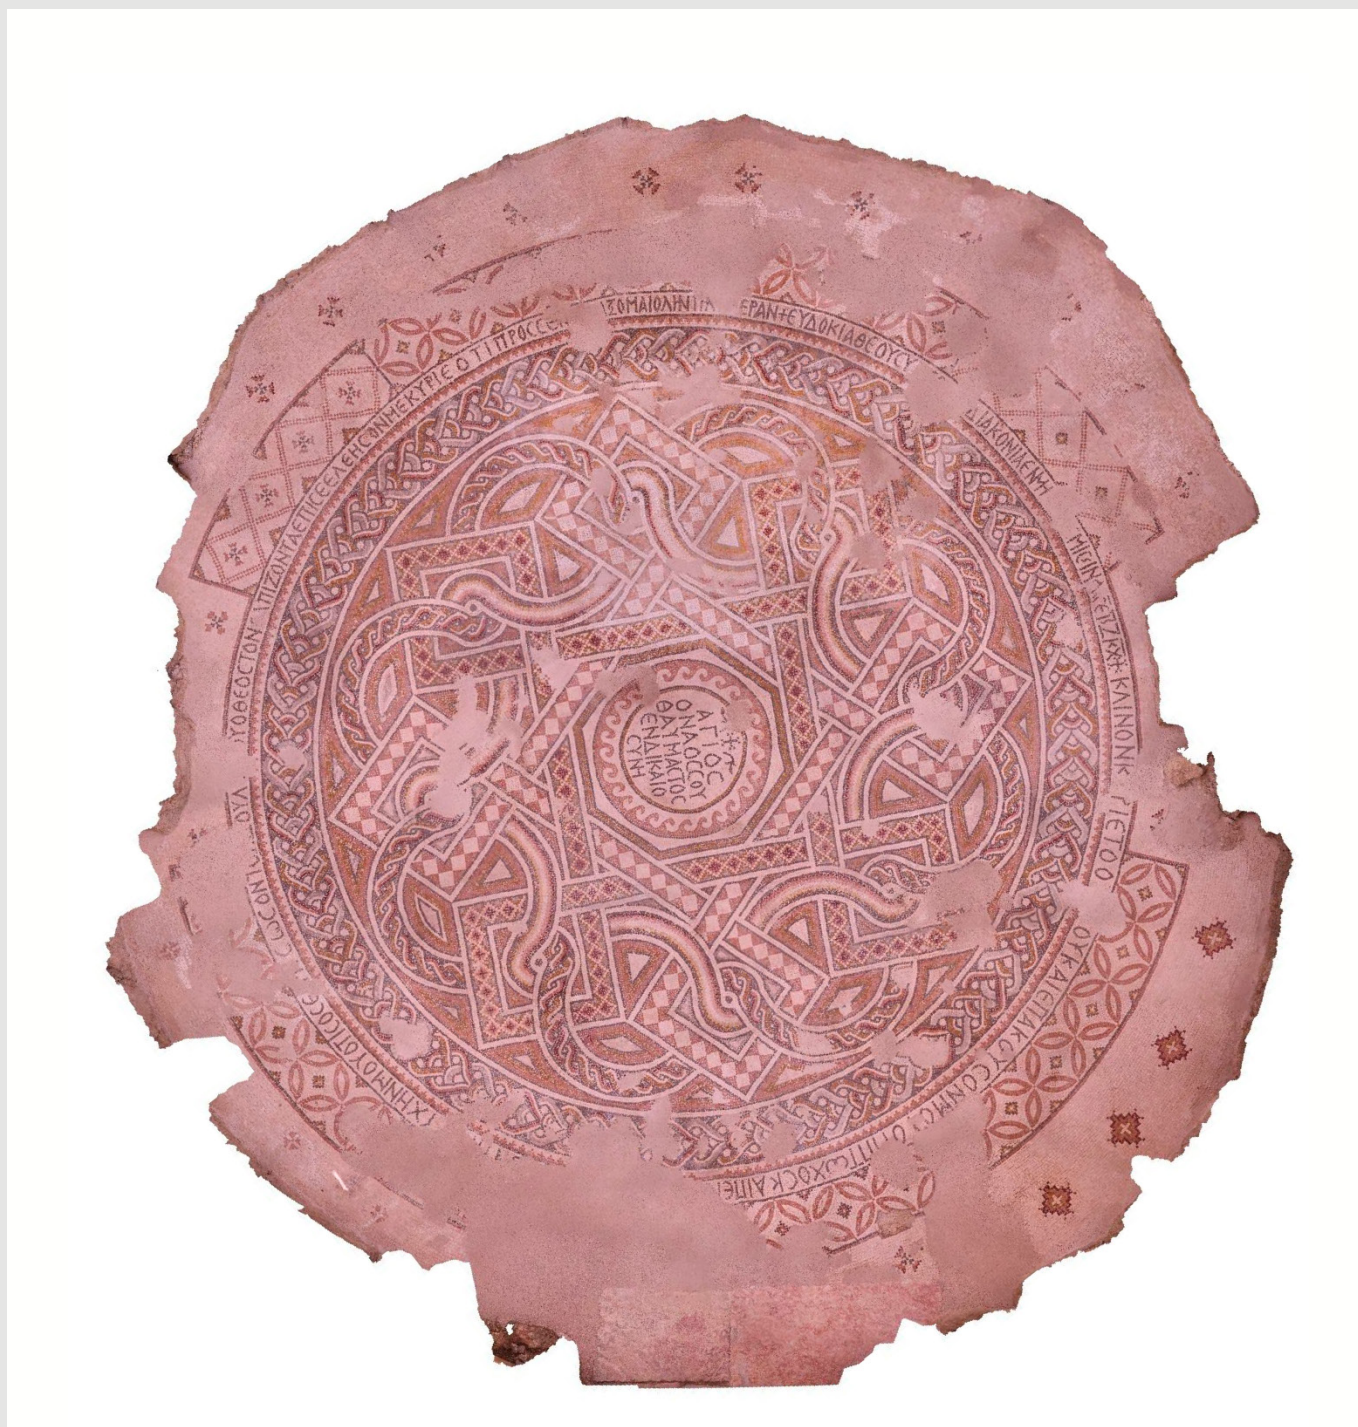
A series of overlapping photos were taken before starting the work to document the mosaic floor after remove the cover, photogrammetric techniques rectified orthophoto for the mosaic floor after the conservation and restoration work in two ways; dry (Fig. 11) and wet (Fig. 12). The floor has been sprayed with water then documented.

**Fig. 10**  
Rectified orthophoto after conservation treatment (dry surface), 2025.

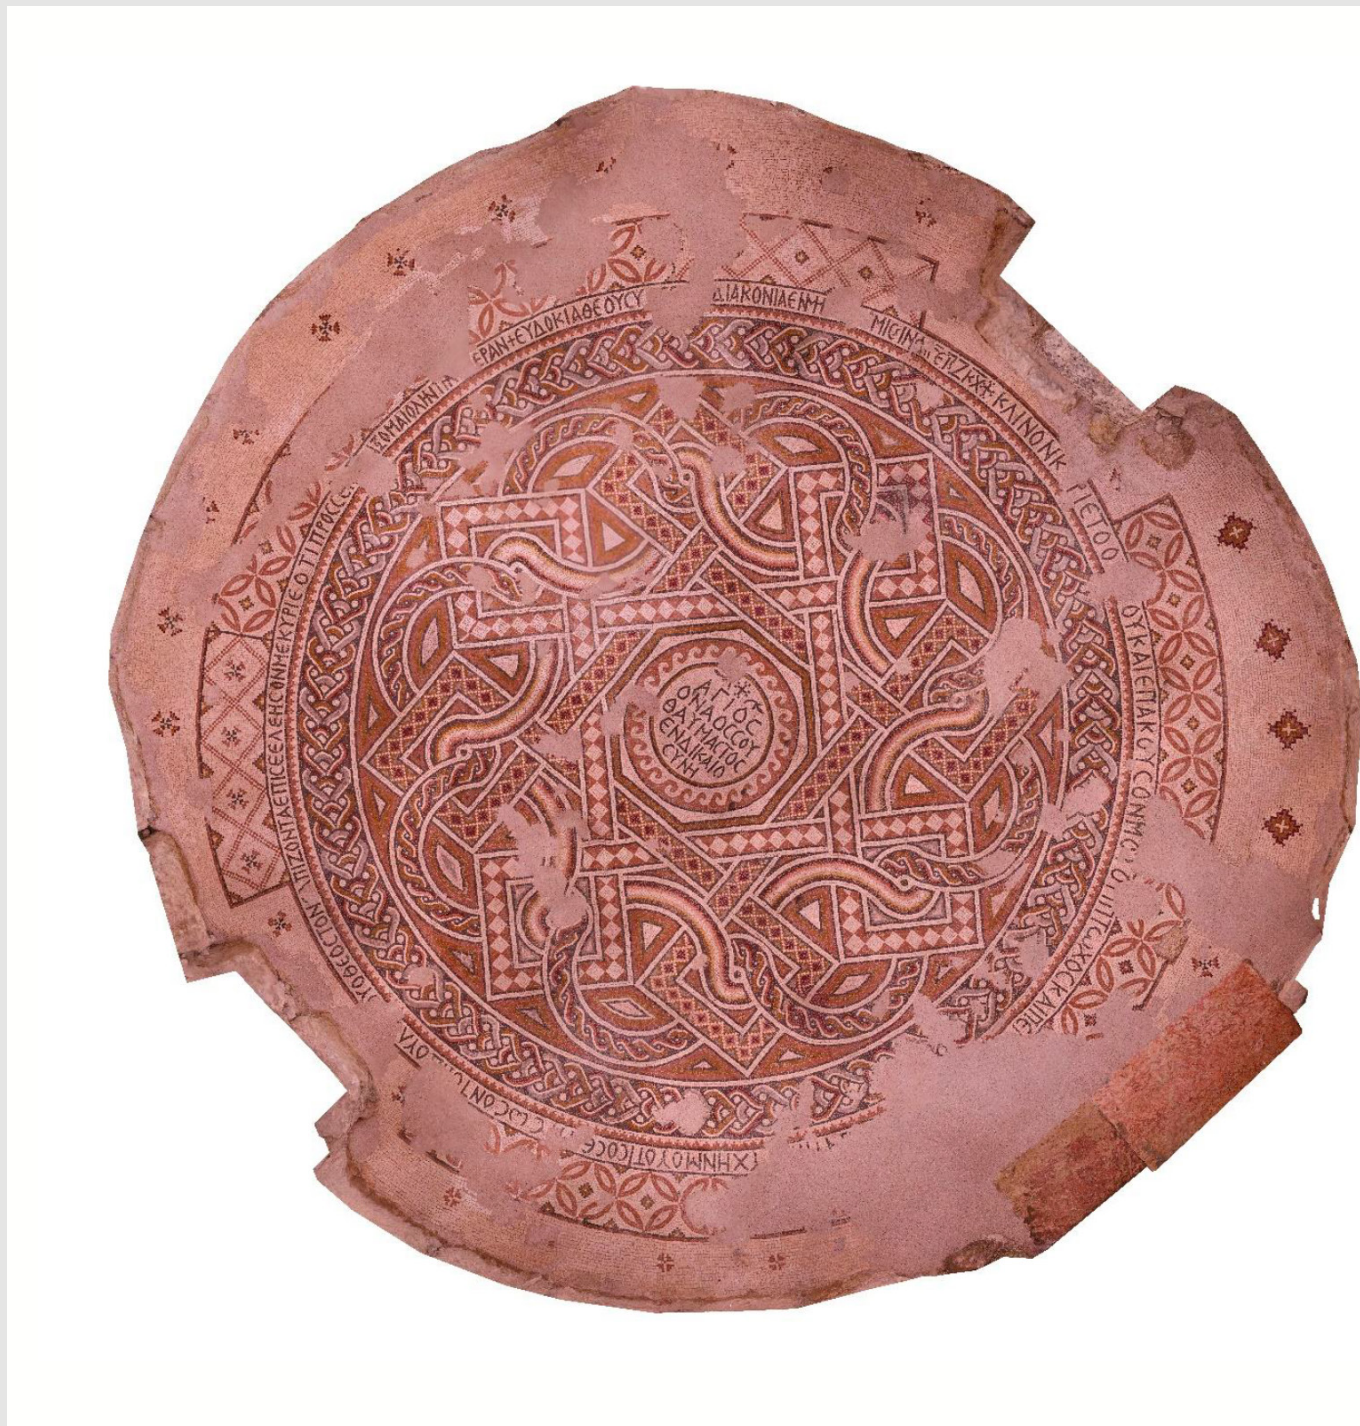
**Fig. 11**

Rectified orthophoto after conservation treatment (wet surface), 2025.

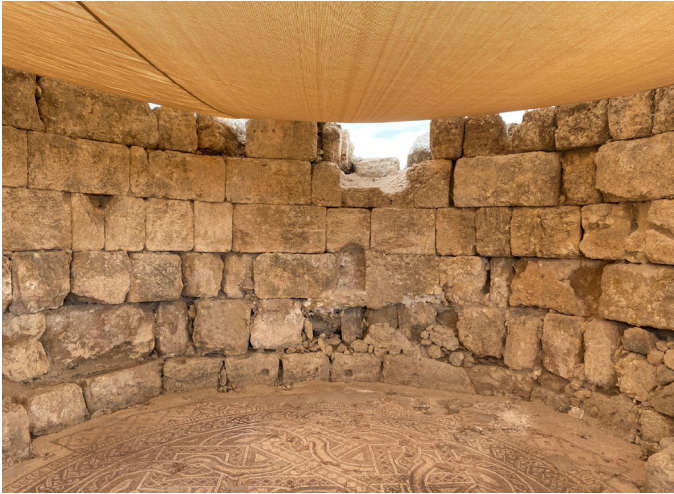
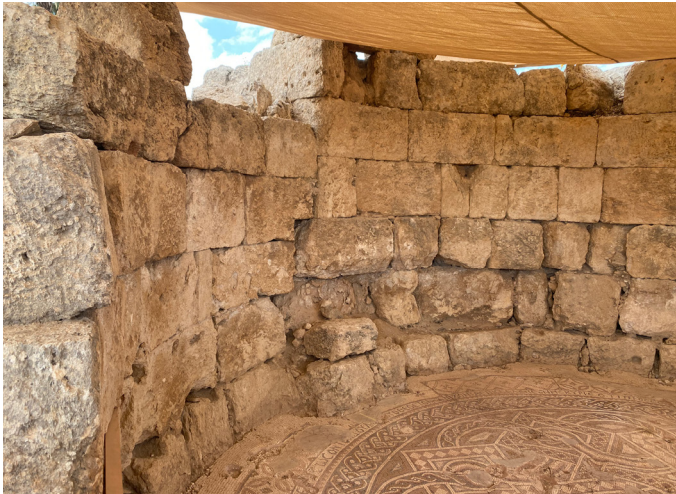
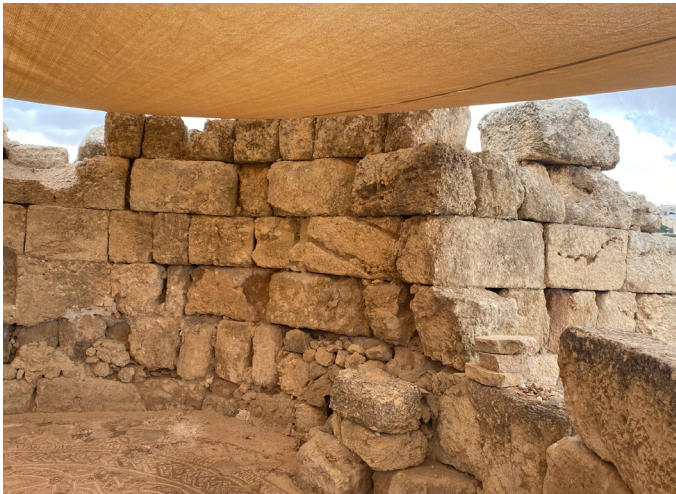
The state of conservation of the masonry surrounding the mosaic is precarious. In particular, the second and third rows of stone blocks show marked deterioration forms, resulting in the loss of extensive surface areas (Fig. 4). The main deterioration forms observed include: erosion, flaking, disintegration and pulverisation. Surface erosion affects all the blocks to varying degrees, primarily due to the action of water combined with the deposition of atmospheric dust.

**Fig. 4**  
General view of the masonry, showing various deterioration forms.

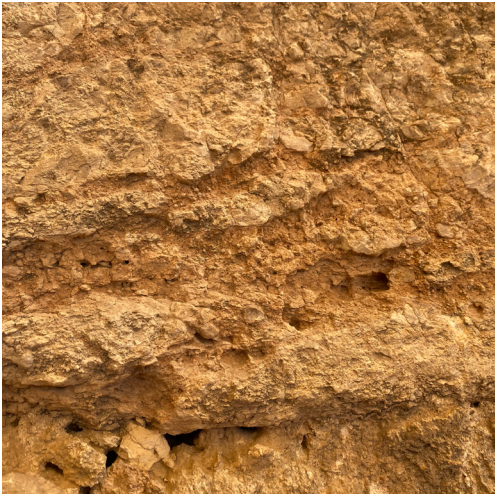
between the intrinsic component contained in the blocks and the yellow-reddish atmospheric dust principal from the ground and deposited on the surfaces. A more advanced stage of degradation is represented by exfoliation/flaking (Figs. 5, 6), caused by sub-surface crystallisation of salts, which are often visible beneath detached flakes. In some areas, white salt efflorescence is also on the surface. An even more severe stage of deterioration is characterised by the disintegration and pulverisation of the stone material (Fig. 7), resulting in the formation of

from left  
**Fig. 5**  
Exfoliation.

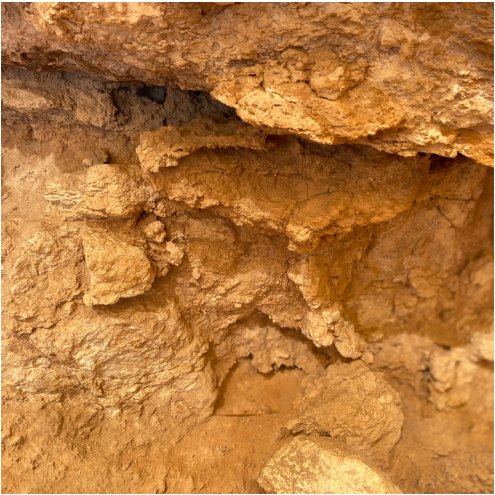
**Fig. 6**  
Flaking.

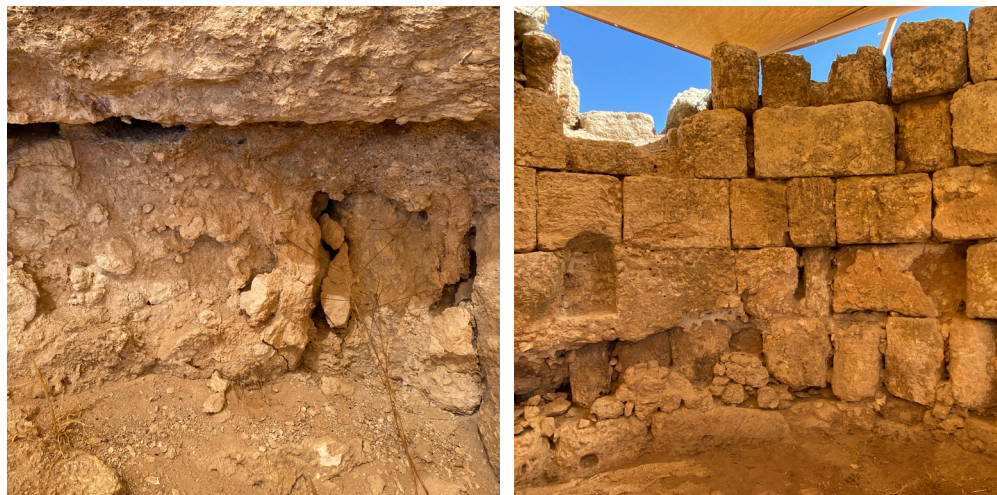
Formation of incoherent  
stone fragments and  
significant loss of material.

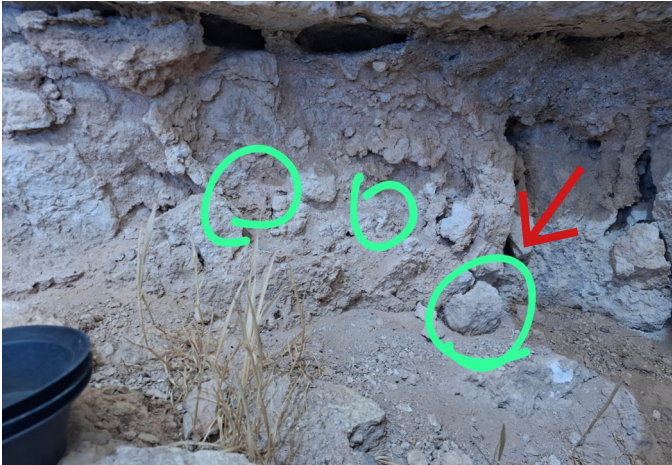
**Fig. 12**  
Sample 2. WAC.

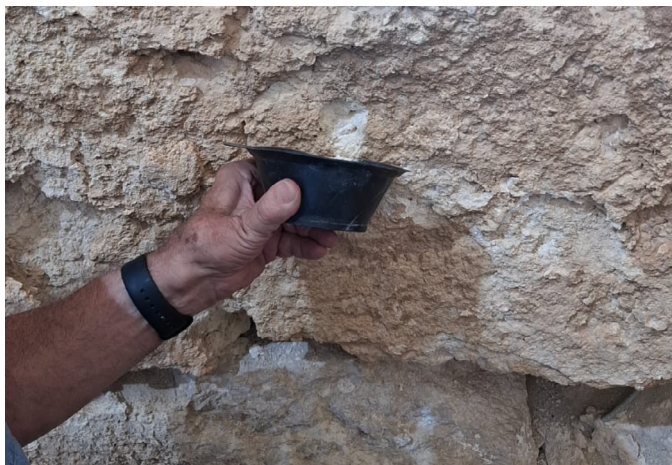
**Fig. 17**  
Sample 5. White powder from the cavity.

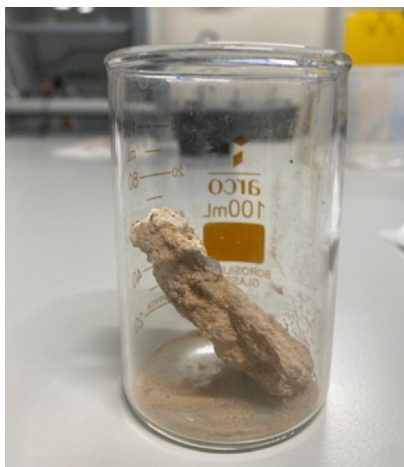
**Fig. 21**  
Sample 6. WA for porosity 9.2 %.

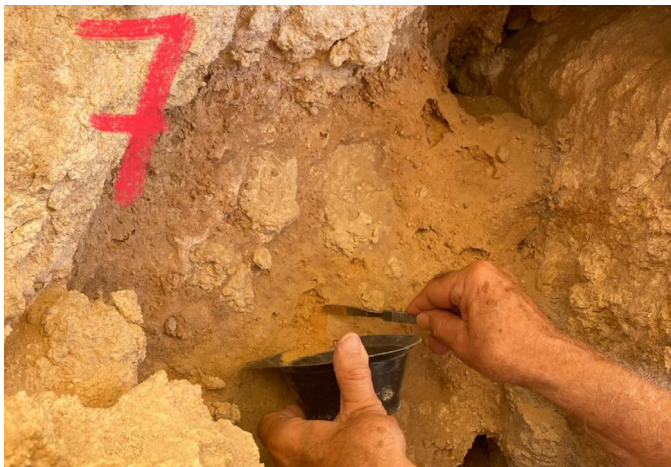
**Fig. 25**  
Sample 7. Red powder.

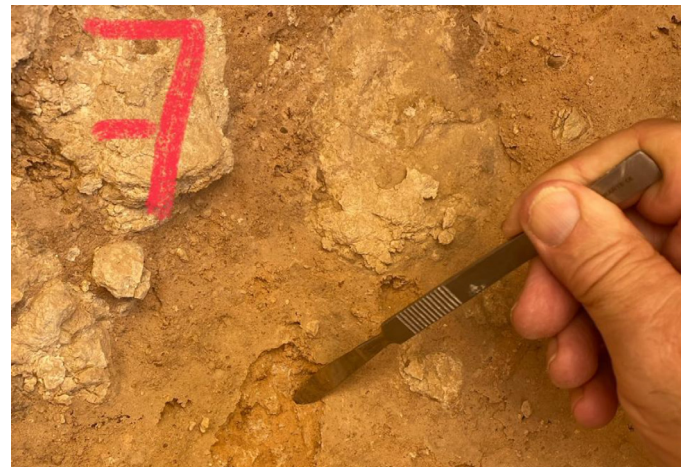
**Fig. 26**  
Sample 7. Red powder.

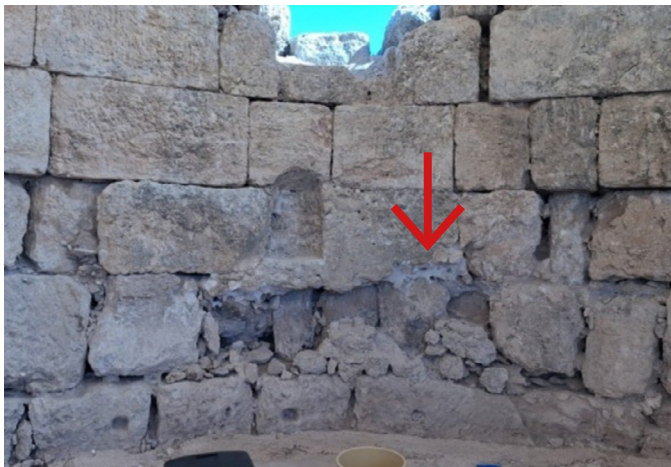
**Fig. 27**  
Sample 8. General view.

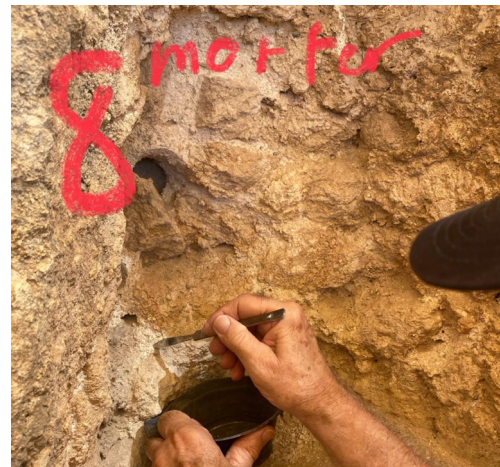
**Fig. 28**  
Sample 8. White mortar.

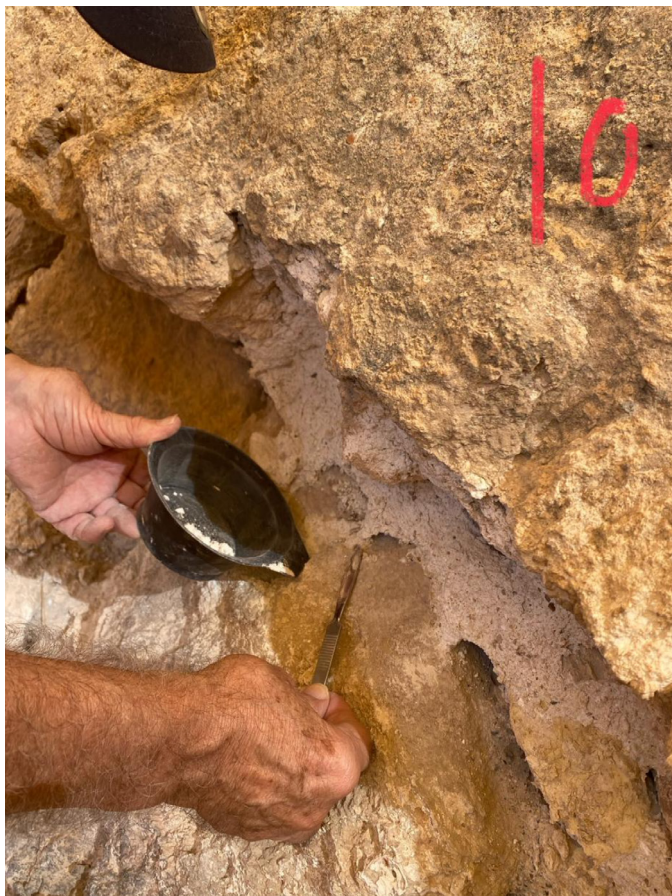
**Fig. 29**  
Sample 10. White mortar powder.

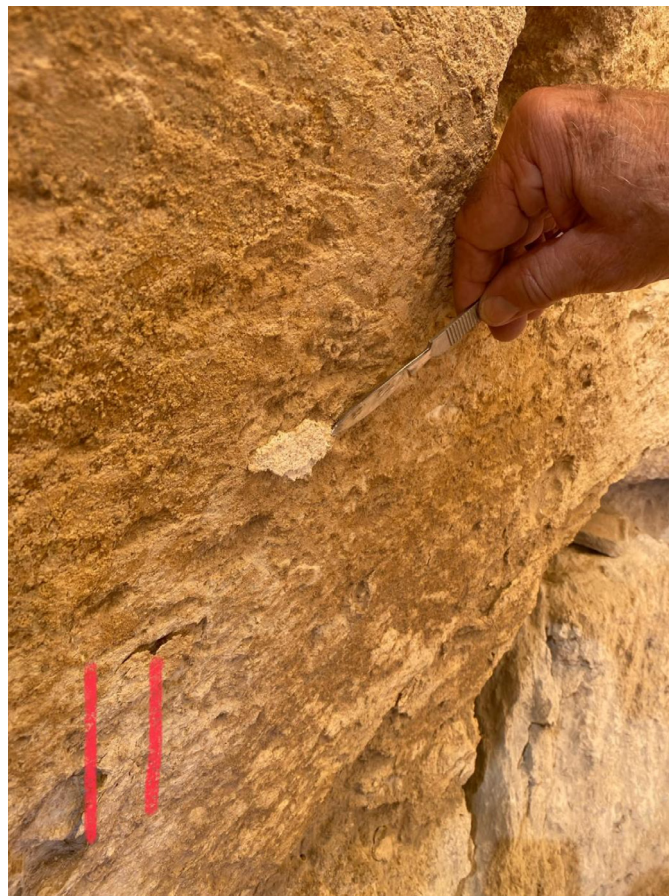
**Fig. 30**  
Sample 11- Plaster.

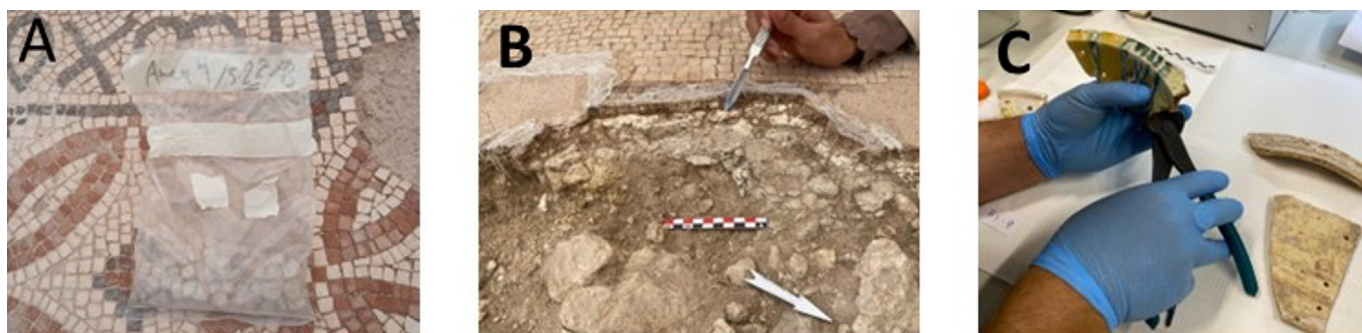
**Fig. 4**

Sampling of tesserae (a), mortars (b) and glazed pottery (c).

Erratic tesserae samples were taken from diaconia mosaic at Jerash site (Figure 4a). Mortar samples were taken from the same mosaic (4 layers) (Figure 4b). Glazed pottery samples were taken from fragmented objects in RCCR coming from Aqaba (Figure 4c).

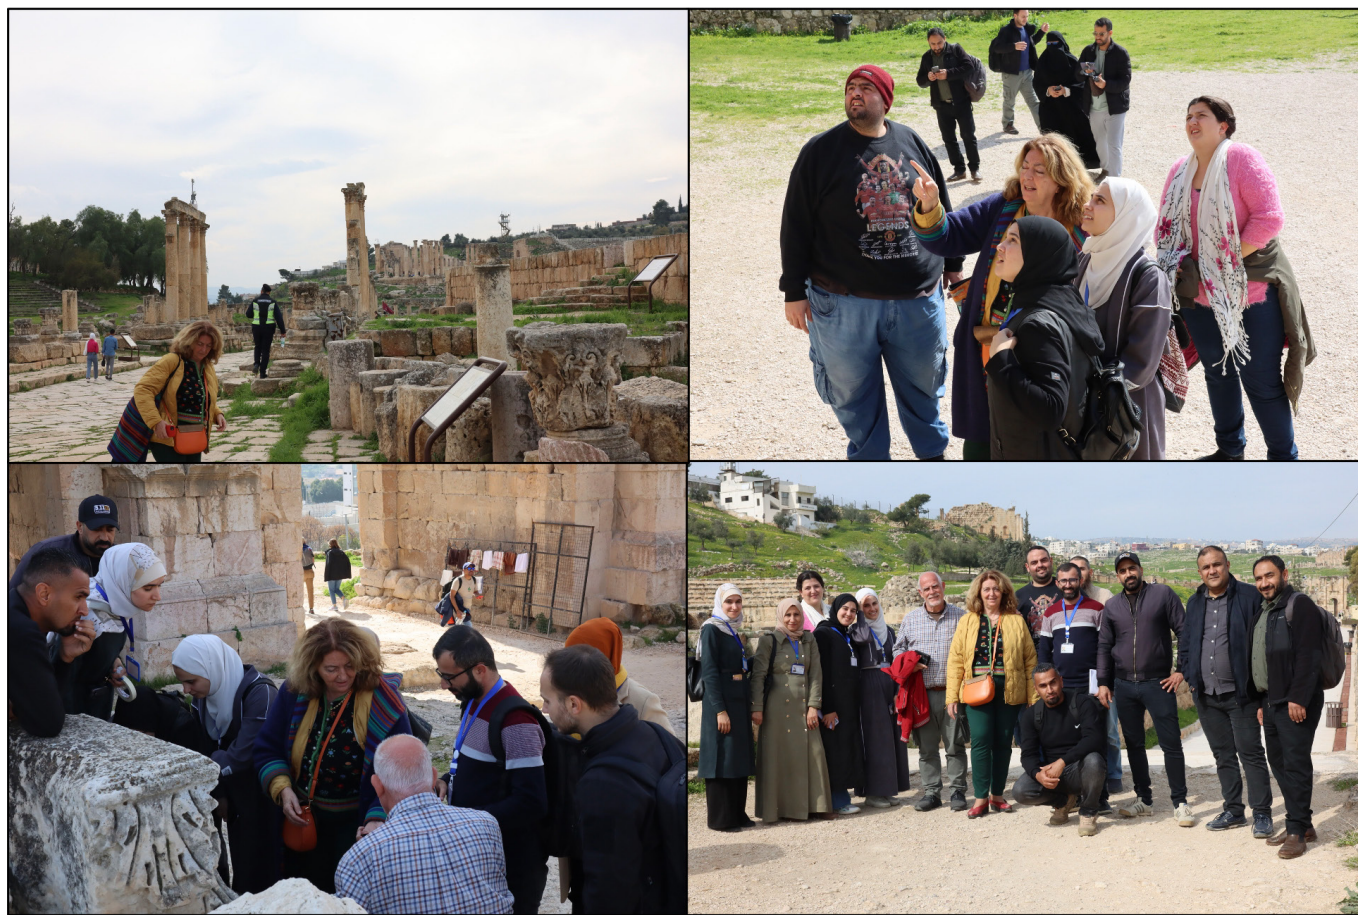
**Fig. 1**

Visit at the archaeological site of Jerash with the class of restorers and observation of phenomenology of stone biodeterioration.

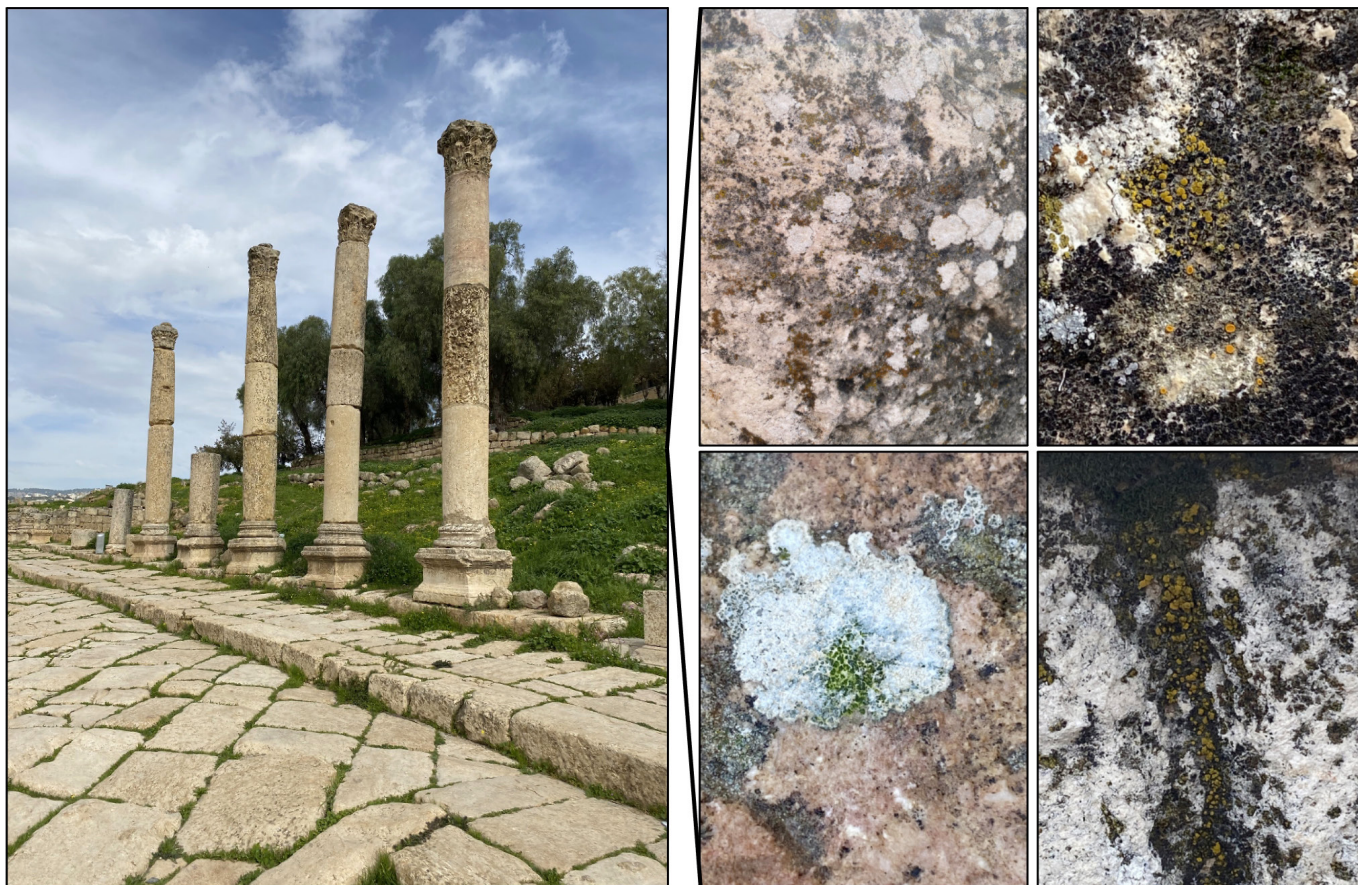
**Fig. 3**

Different Biodeterioration patterns due to lichens (epilithic crusts of various color) and cyanobacteria (blackish biofilm) in the archaeological site of Jerash.

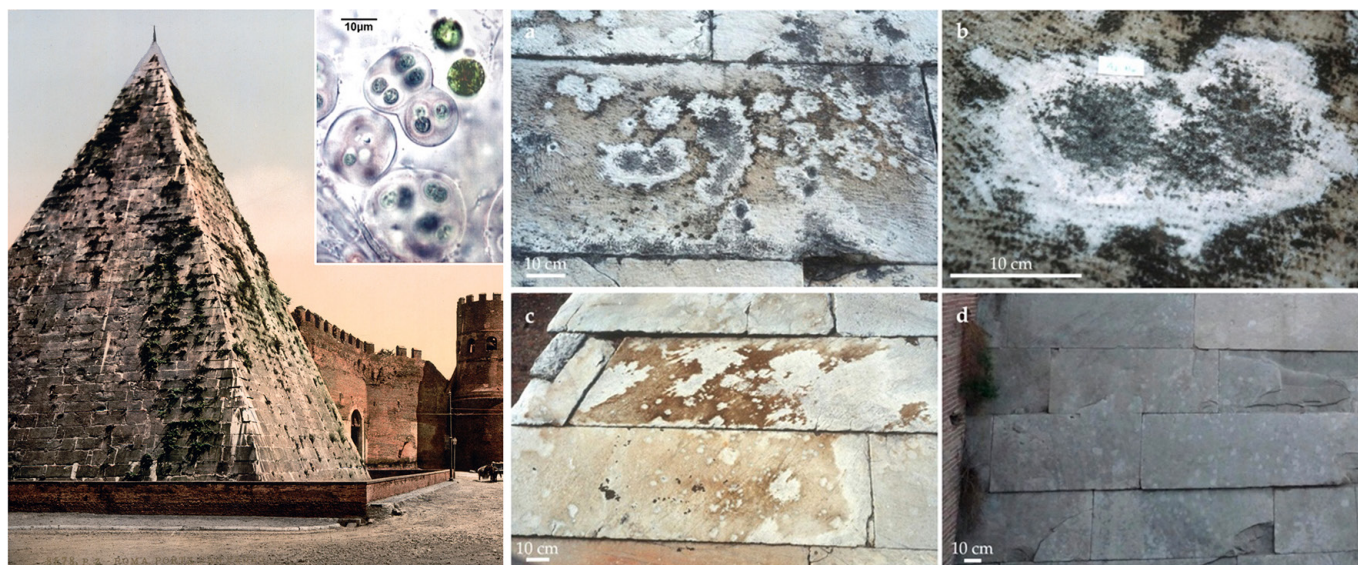
**Fig. 5**

The Caestia Pyramid in Rome (Italy) and its colonization at the beginning of 20th century. (a,b) Biodeterioration patterns (BPs), observed in 1992, related to previous lichen colonization with cyanobacterial regrowth in central areas (c) lichens detachment (whitish surfaces) surrounded by brownish patinas caused by organic compounds and further bacterial and fungal growths (d) whitish circular areas related to past occurrence of lichen thalli, without a subsequent microbial colonization (2017) (from Caneva et al., 2020a).

Furthermore, the detection of previous colonization tracks of lichens can have practical application for stone conservation, as in the case of the marble surfaces of the *Caestia* Pyramid in Rome (Italy) (Caneva et al. 2020a). On this structure, the presence of recognizable tracks of previous lichen colonization and the evident inhibition areas of subsequent cyanobacterial establishment (Fig. 5) demonstrated the long-lasting, allelopathic properties of some lichen metabolites (e.g., aspicilin, usnic acid), suggesting a future research direction in natural biocides (Caneva et al. 2020a).

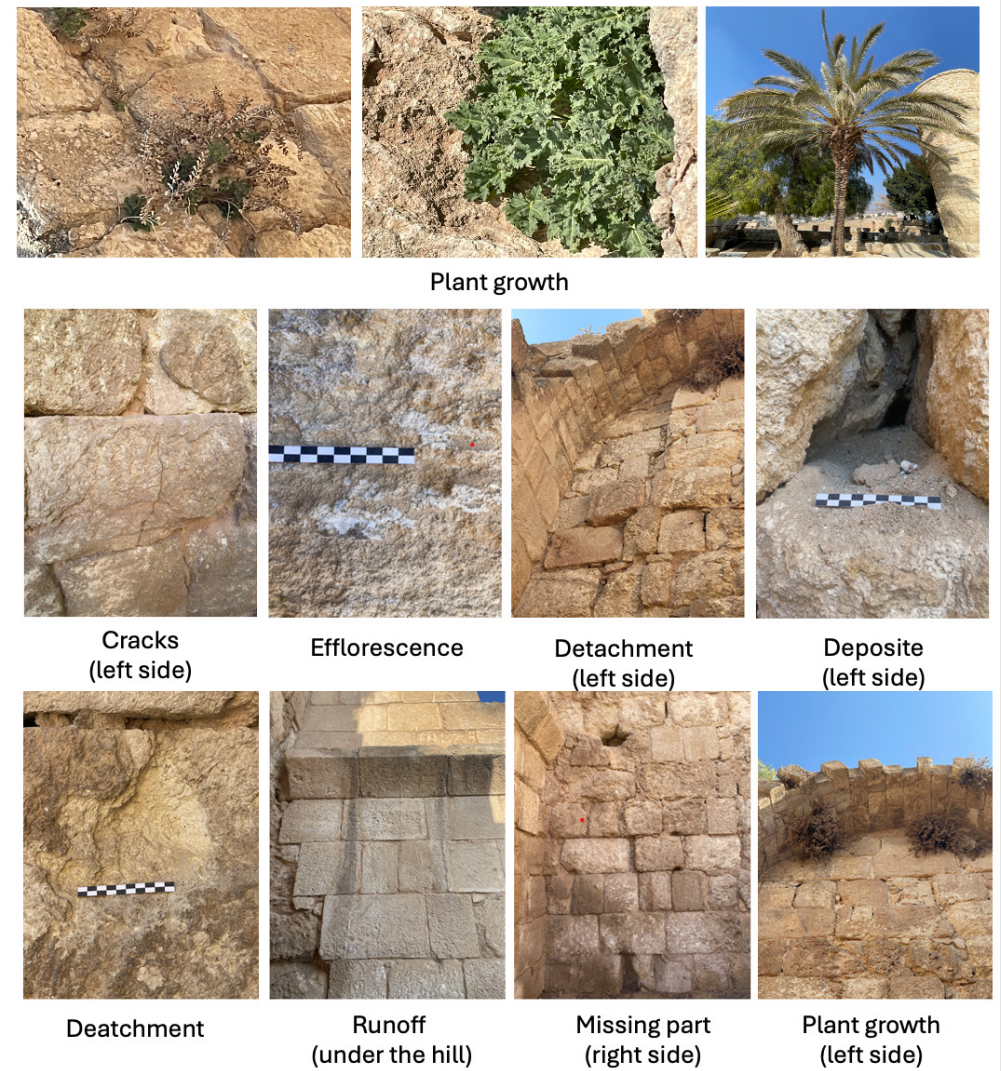
**Fig. 3**  
Main degradation phenomena identified and documented on the examined surfaces.

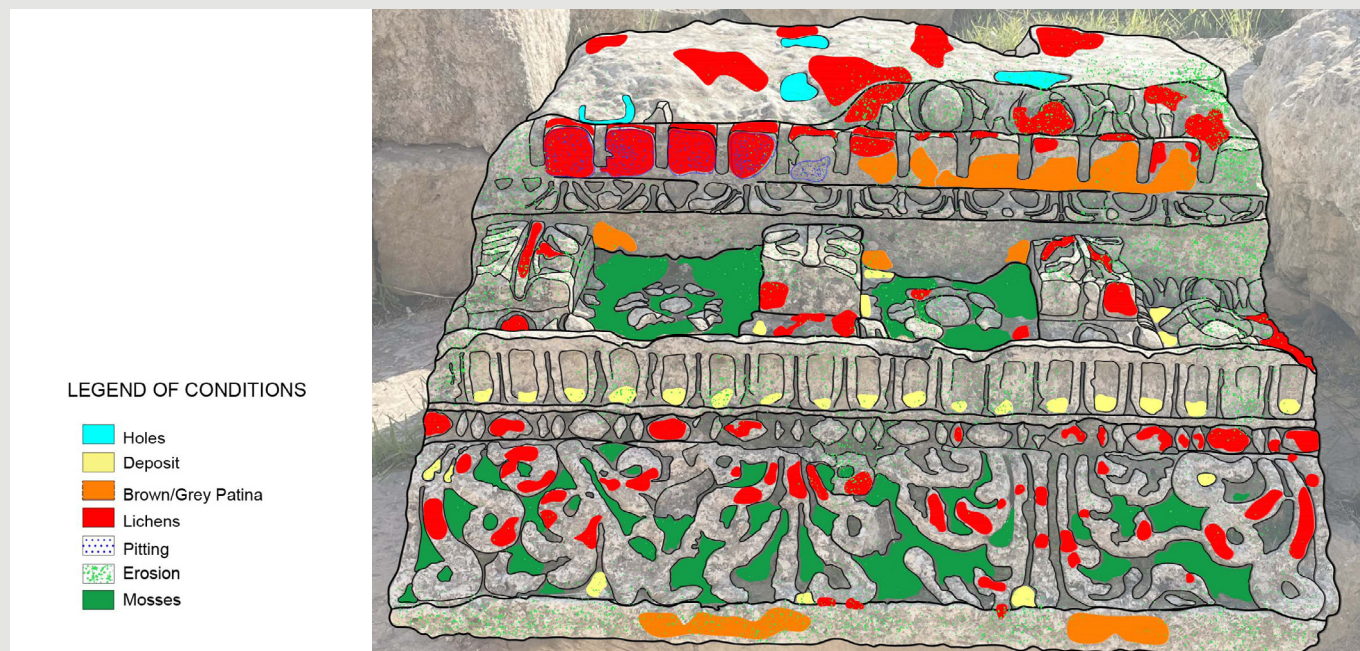
**Fig. 5**

Mapping of the degradation of the architectural element taken as an additional reference (Graphic elaboration by Eng. T. A. Albataineh).

To further investigate and better understand the degradation phenomena and biological colonisation affecting this area of the site, an additional architectural element was selected as a comparative reference (Fig. 5). This element is located opposite the façade under study but is characterised by a different orientation.

It consists of an architectural fragment exhibiting extensive and well-established biological colonisation. The element is situated in a more shaded area, and its decorative features and mouldings promote the retention and accumulation of rainwater. These microenvironmental conditions favour the development of biological patinas and
